To all Members of the Open Spaces Committee

You are hereby summoned to attend a meeting of the **OPEN SPACES COMMITTEE** at the Parish Office, Lower Green Recreation Ground, Pembury, TN2 4DZ on **Monday 30th September** at **3:00pm**.

8. **LOWER GREEN RECREATION GROUND.**
 - a. To receive RoSPA annual inspection report for play equipment and note recommendations.
 - b. To consider the option for football club to be able to store new goals on wheels in the outside section of the goal store area at the Pavilion.
 - c. To report on the meeting at Hilbert Park and consider next steps.
 - d. To consider recreation ground consultation report and agree next steps.
 - e. To consider improvements and new play equipment funded by section 106 and agree next steps.

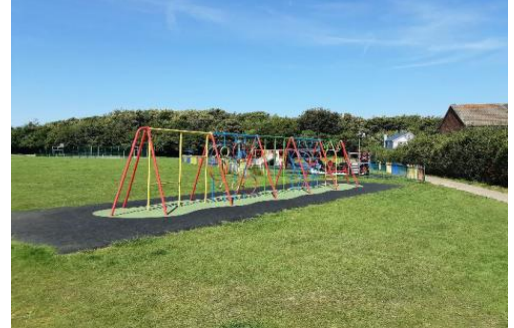
Item: Site General
Manufacturer: Owner/Operator
Surface Type: N/A
Item Quantity: 1
Equipment Compliance: N/A
Surface Area Compliance: N/A

There is weed / vegetation growth on, between, or around the edges of the surfacing - Remove weed / vegetation growth

The surface is lifting at the edges and creating trip points - Repair perimeter of surfacing to remove trip points

The safety surface around the area is beginning to wear - Monitor for any further deterioration and repair as required

The surfacing around the gym equipment is crumbling in areas creating slippery conditions - Sweep and clear all loose debris and monitor

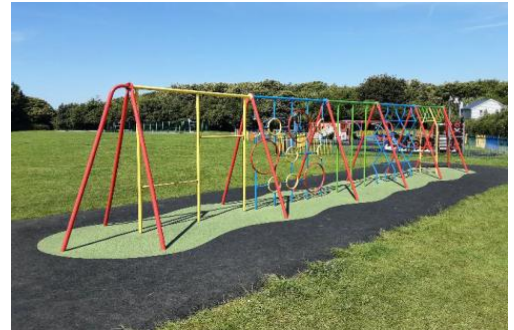
Item: Climbing Frame
Manufacturer: Not Identified
Surface Type: Bitmac
Item Quantity: 1
Equipment Compliance: No
Surface Area Compliance: Yes

The paint is flaking off the metalwork - Rub down and re-paint

The item fails to meet the requirements of BS EN 1176 Part 1 4.2.7.2 for head and neck entrapment in the frame - Monitor - No remedial work recommended

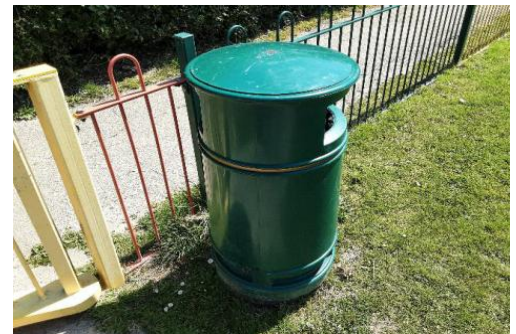
Item: Litter Bin
Manufacturer: Owner/Operator
Surface Type: Grass
Item Quantity: 3
Equipment Compliance: N/A
Surface Area Compliance: N/A

The item has been damaged - Monitor for any further deterioration and replace as required

i 6 - Low Risk

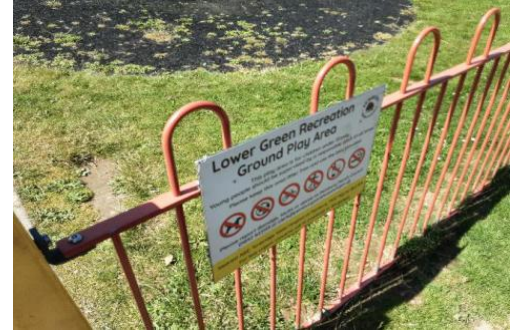
Item: Sign
Manufacturer: Owner/Operator
Surface Type: Grass
Item Quantity: 1
Equipment Compliance: N/A
Surface Area Compliance: N/A

Cable ties have been used on the item and there are sharp projecting ends - Remove if not required or replace with a more appropriate alternative fixing method if used as a fixing

i 8 - Low Risk

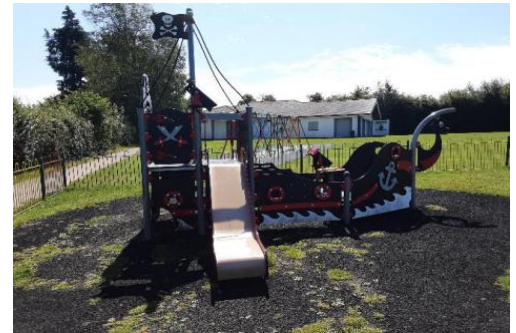
Item: Ship (Pirate)
Manufacturer: Mant Leisure
Surface Type: Wet Pour
Item Quantity: 1
Equipment Compliance: Yes
Surface Area Compliance: Yes

There is moderate damage to the surface - Repair the damaged areas of surfacing

A number of fixing(s) have worked loose - Secure all loose fixings

There is/are inserts missing - Replace missing inserts

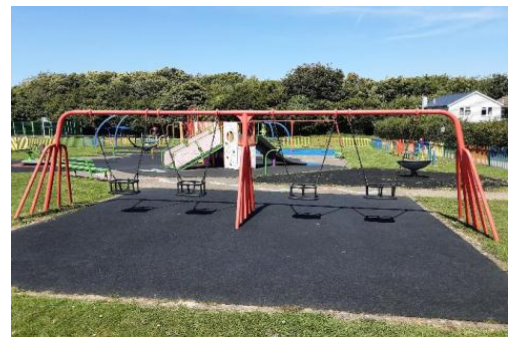
Item: 2 Bay 4 Seat (Cradle)
Manufacturer: Wicksteed Playgrounds
Surface Type: Wet Pour
Item Quantity: 1
Equipment Compliance: No
Surface Area Compliance: Yes

The chain openings are in excess of the 8.6mm as recommended by BS EN 1176 - Monitor - No remedial work recommended</p> | <p>Finding 2
 There is some notable evidence of chain wear - Monitor for any further deterioration and replace when 40% worn</p> |

There is some wear to the shackles. - Monitor for any further deterioration and replace when 40% worn</p> | <p>Finding 4
 The seat has minor damage or wear - Monitor for any further deterioration and replace as required</p> |

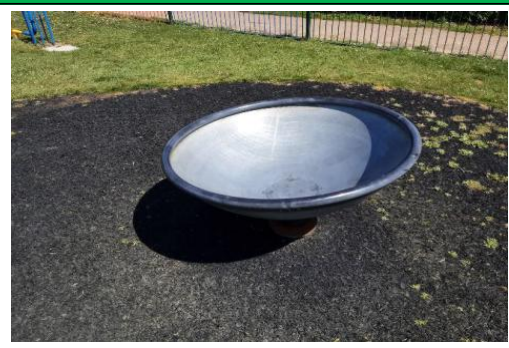
Item: Dish Roundabout
Manufacturer: Mant Leisure
Surface Type: Wet Pour
Item Quantity: 1
Equipment Compliance: Yes
Surface Area Compliance: Yes

- Finding 1**
 The paintwork on this item has been damaged or worn exposing the metal underneath which is rusting / corroding - Treat affected areas and repaint

i 4 - Very Low Risk

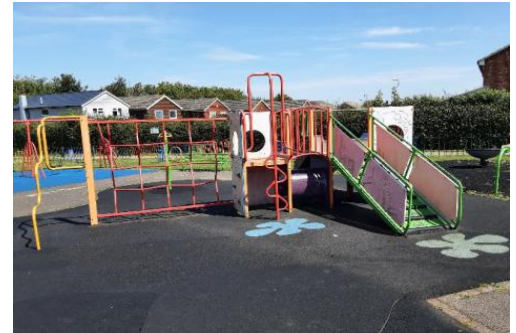
Item: Multi Play (Junior)
Manufacturer: Wicksteed Playgrounds
Surface Type: Wet Pour
Item Quantity: 1
Equipment Compliance: Yes
Surface Area Compliance: No

The surfacing dimensions are short and do not meet with the requirements of the current applicable standard - Monitor - no remedial action recommended

There is some minor damage to the surface - Monitor for any further deterioration and repair as required

There are a number of dents in the slide surface - Monitor for any further deterioration and repair as required

There is a split in the slide surface - Repair slide

i 6 - Low Risk

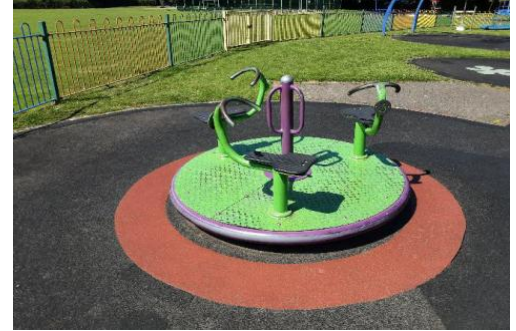
Item: Roundabout
Manufacturer: Wicksteed Playgrounds
Surface Type: Wet Pour
Item Quantity: 1
Equipment Compliance: Yes
Surface Area Compliance: Yes

The paintwork on this item has been damaged or worn exposing the metal underneath which is rusting / corroding - Treat affected areas and repaint

i 6 - Low Risk

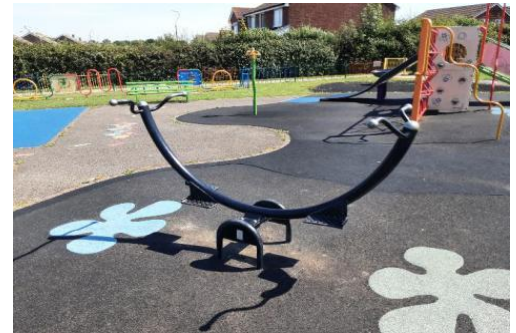
Item: Stand up SeeSaw
Manufacturer: Wicksteed Playgrounds
Surface Type: Wet Pour
Item Quantity: 1
Equipment Compliance: Yes
Surface Area Compliance: Yes

The paintwork on this item has been damaged or worn exposing the metal underneath which is rusting / corroding - Treat affected areas and repaint

i 6 - Low Risk

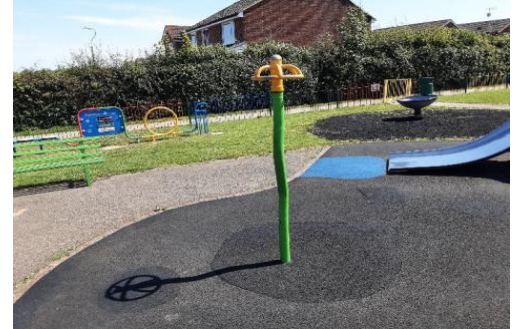
Item: Overhead Rotator
Manufacturer: Wicksteed Playgrounds
Surface Type: Wet Pour
Item Quantity: 1
Equipment Compliance: Yes
Surface Area Compliance: Yes

The bearing is showing signs of wear - Monitor for any further deterioration and replace as required

i 8 - Low Risk

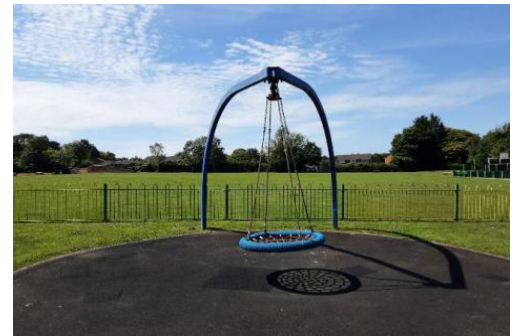
Item: Single Point Swing - Type 3
Manufacturer: Wicksteed Playgrounds
Surface Type: Wet Pour
Item Quantity: 1
Equipment Compliance: Yes
Surface Area Compliance: No

The safety surface around the area is beginning to wear - Monitor for any further deterioration and repair as required

The surfacing dimensions are short and do not meet with the requirements of the current applicable standard - Monitor - no remedial action recommended

The seat has minor damage or wear - Monitor for any further deterioration and replace as required

The manufacturer of this product makes a recommendation that the universal swing joint should be replaced at 5 year intervals. Usually there is an ID tag present stating the date the joint was last replaced, however there is no tag present on this joint which would indicate that it has not been replaced recently - Consult with manufacturer for replacement part

There is some wear to the shackles. - Monitor for any further deterioration and replace when 40% worn

i 6 - Low Risk

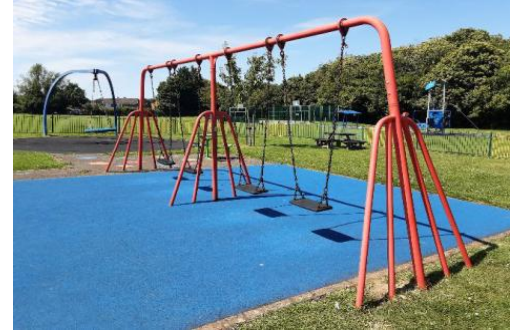
Item: 2 Bay 4 Seat (Flat)
Manufacturer: Wicksteed Playgrounds
Surface Type: Wet Pour
Item Quantity: 1
Equipment Compliance: No
Surface Area Compliance: Yes

The chain openings are in excess of the 8.6mm as recommended by BS EN 1176 - Monitor - No remedial work recommended

The seat has minor damage or wear - Monitor for any further deterioration and replace as required

There is some notable evidence of chain wear - Monitor for any further deterioration and replace when 40% worn

There is some wear to the shackles. - Monitor for any further deterioration and replace when 40% worn

The bushes are showing signs of wear - Monitor for any further deterioration and replace as required

The swing seat connectors have some wear present - Monitor for further deterioration and replace when 40% worn

i 6 - Low Risk

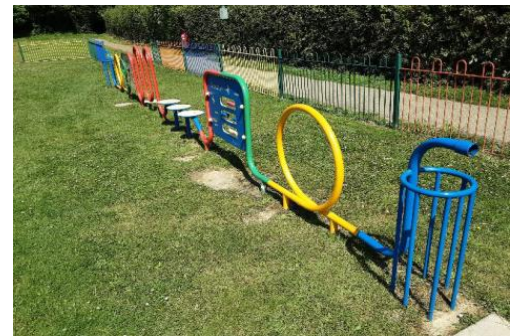
Item: Activity Trail
Manufacturer: Wicksteed Playgrounds
Surface Type: Grass
Item Quantity: 1
Equipment Compliance: Yes
Surface Area Compliance: Yes

The surface has eroded in some areas and may be slippery in wet conditions - Reinststate the surface

i 9 - Low Risk

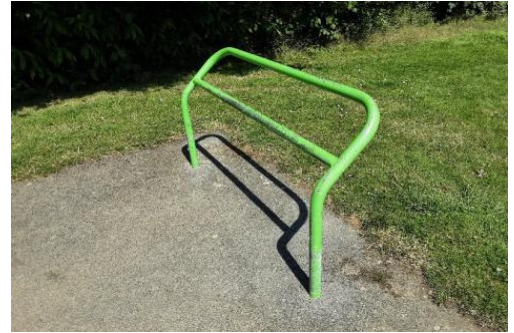
Item: Perch Seat
Manufacturer: Wicksteed Playgrounds
Surface Type: Bitmac
Item Quantity: 3
Equipment Compliance: N/A
Surface Area Compliance: N/A

Finding 1
 The paint is flaking off the metalwork - Rub down and re-paint

i 6 - Low Risk

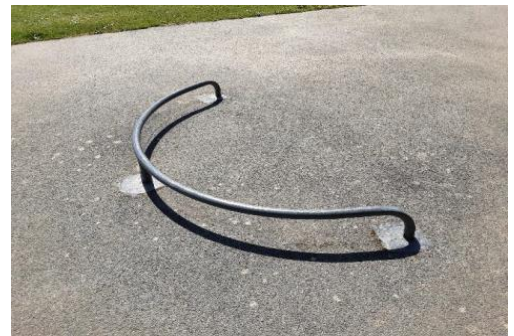
Item: Curved Grind Rail
Manufacturer: Not Identified
Surface Type: Bitmac
Item Quantity: 1
Equipment Compliance: Yes
Surface Area Compliance: Yes

Finding 1
 The item has been damaged - Monitor for any further deterioration and replace as required

i 6 - Low Risk

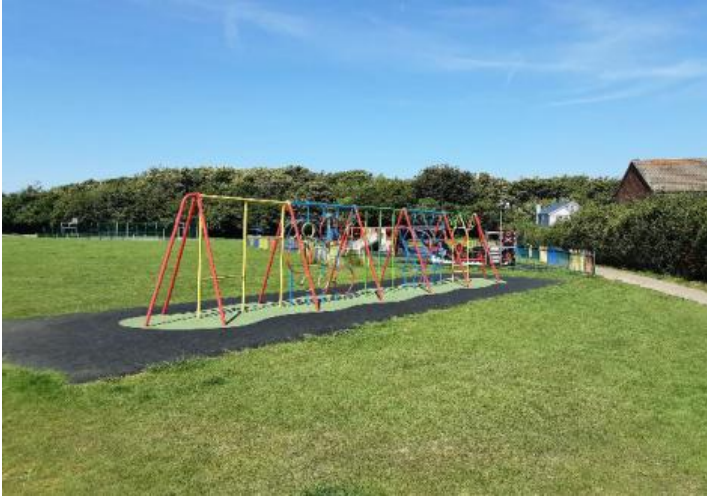
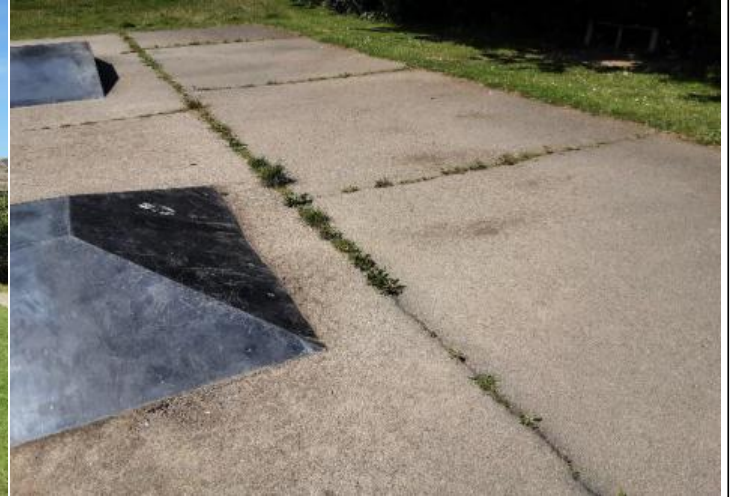
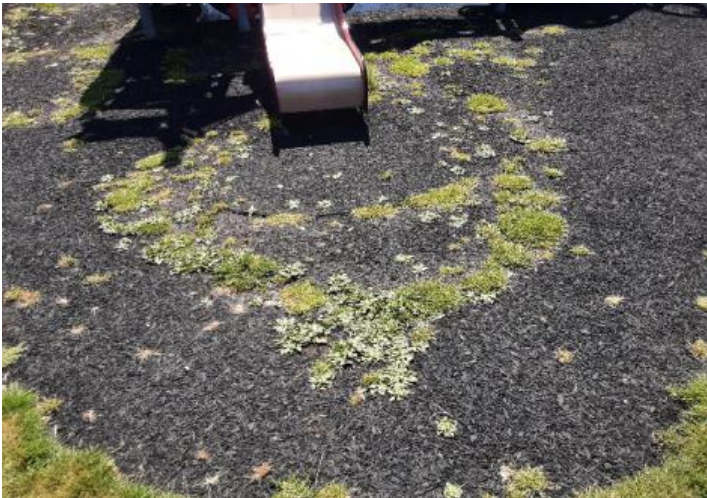
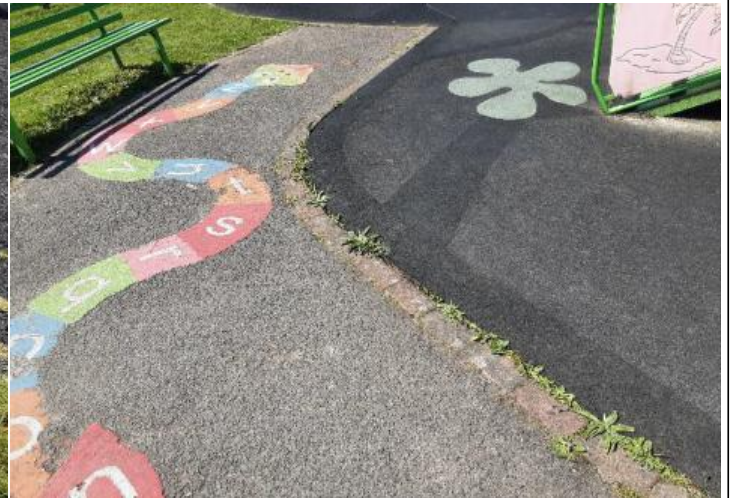
Item: Ancillary Items - Site General
Manufacturer: Owner/Operator

Finding: There is weed / vegetation growth on, between, or around the edges of the surfacing
Action: Remove weed / vegetation growth

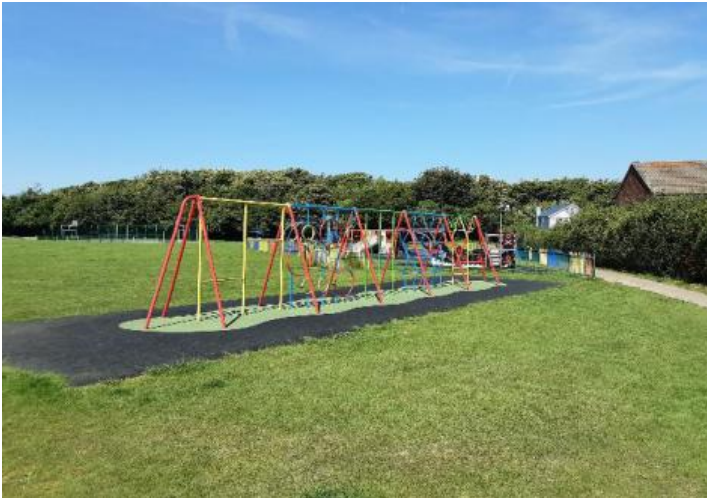
Item: Ancillary Items - Site General
Manufacturer: Owner/Operator

Finding: The surface is lifting at the edges and creating trip points **Action:** Repair perimeter of surfacing to remove trip points

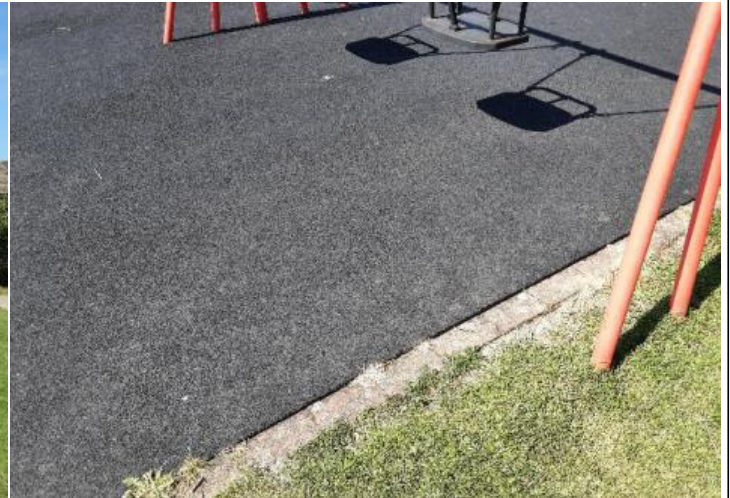
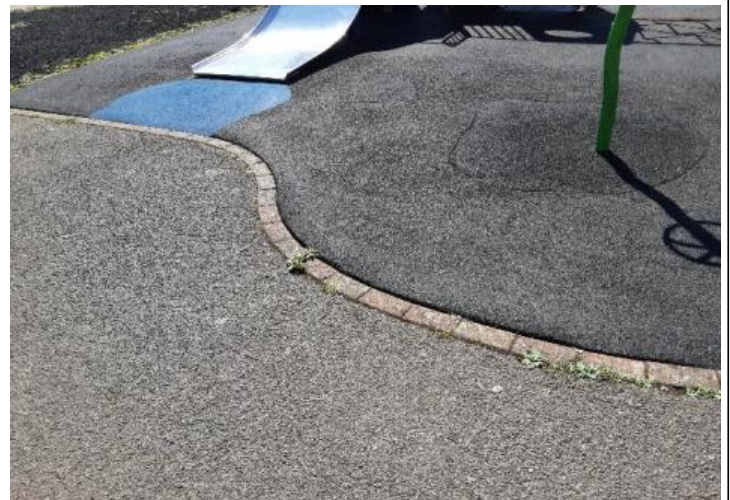
Risk Level: L - Low Risk
Surface: N/A

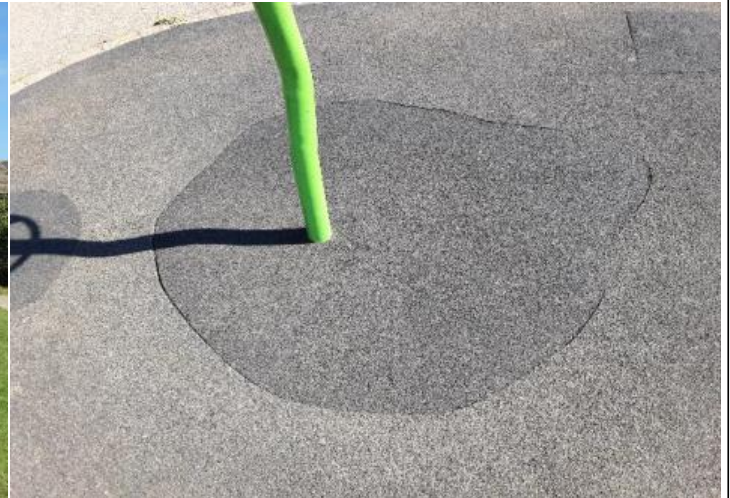
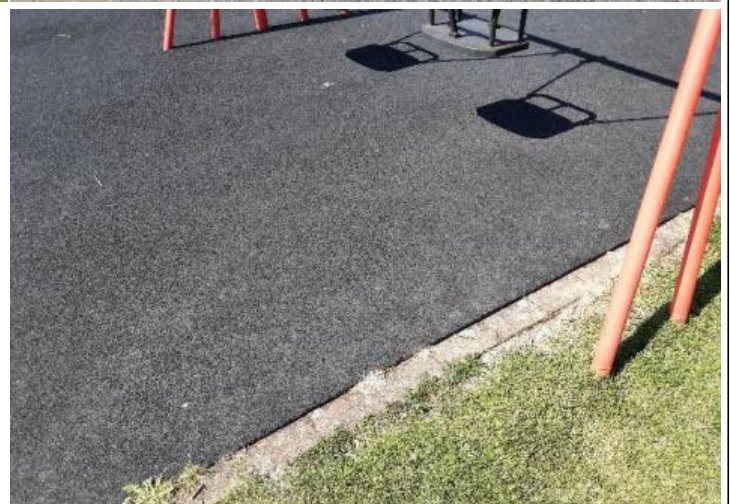
Risk Level: L - Low Risk
Surface: N/A

Finding: The safety surface around the area is beginning to wear

Action: Monitor for any further deterioration and repair as required

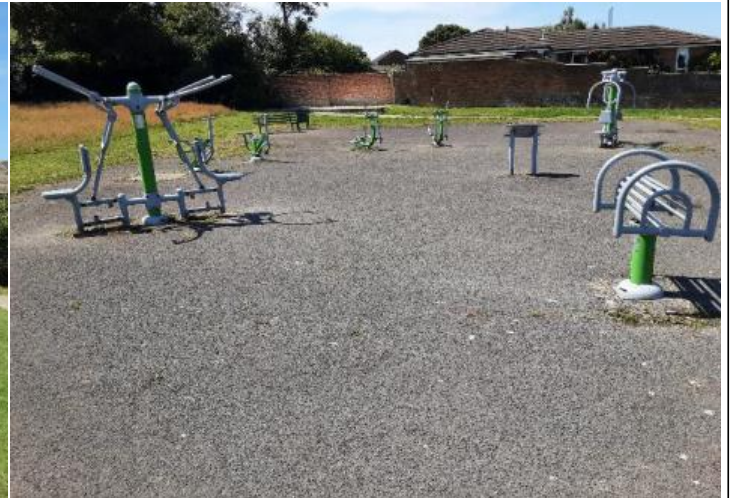
Risk Level: L - Low Risk
Surface: N/A

Finding: The surfacing around the gym equipment is crumbing in areas creating slippery conditions

Action: Sweep and clear all loose debris and monitor

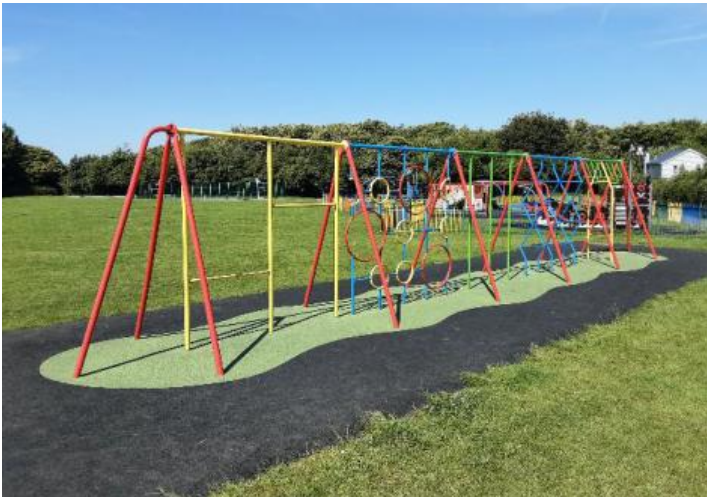
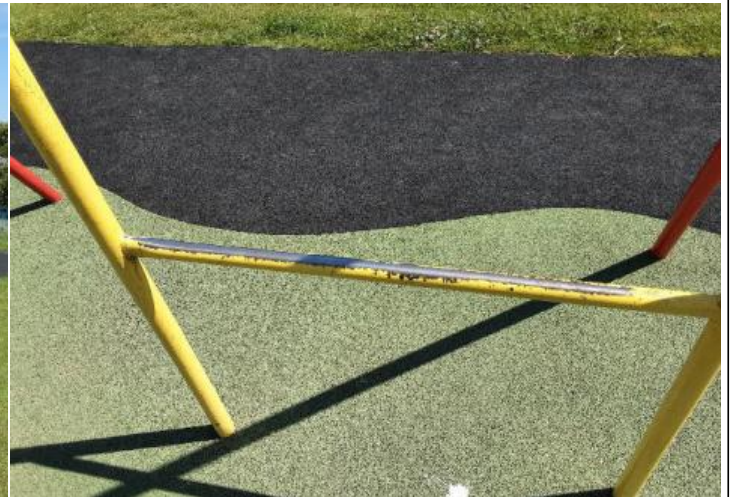
Item: Activity Equipment - Climbing Frame
Manufacturer: Not Identified

Finding: The paint is flaking off the metalwork

Action: Rub down and re-paint

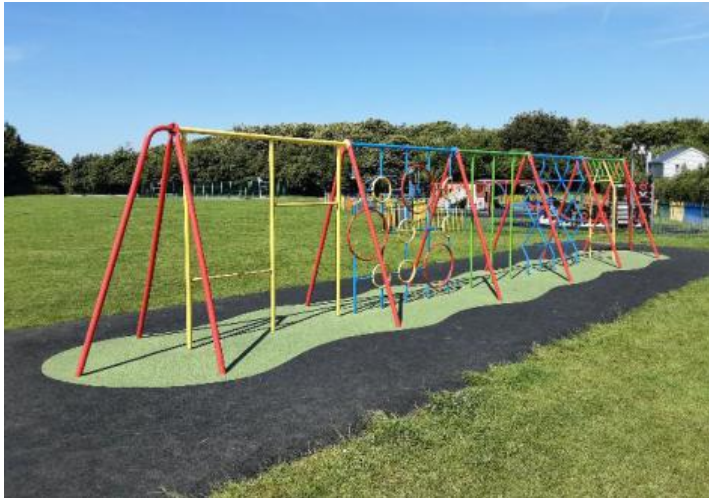
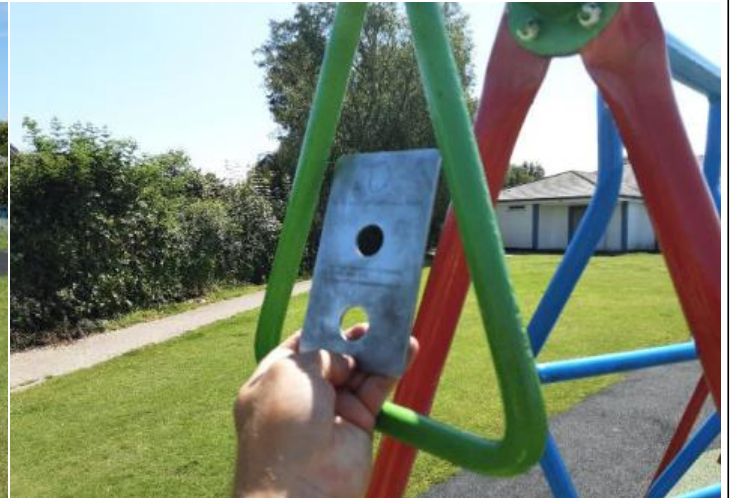
Risk Level: V - Very Low Risk
Surface: Bitmac

Finding: The item fails to meet the requirements of BS EN 1176 Part 1 4.2.7.2 for head and neck entrapment in the frame

Action: Monitor - No remedial work recommended

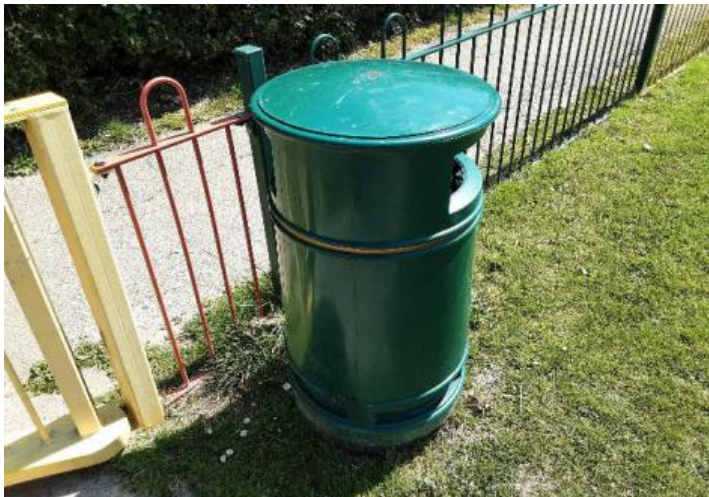
Item: Ancillary Items - Litter Bin
Manufacturer: Owner/Operator

Finding: The item has been damaged

Action: Monitor for any further deterioration and replace as required

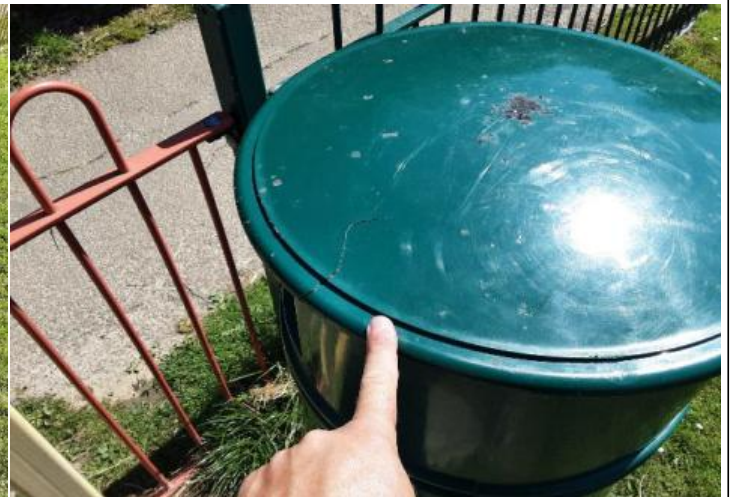
Risk Level: L - Low Risk
Surface: Grass

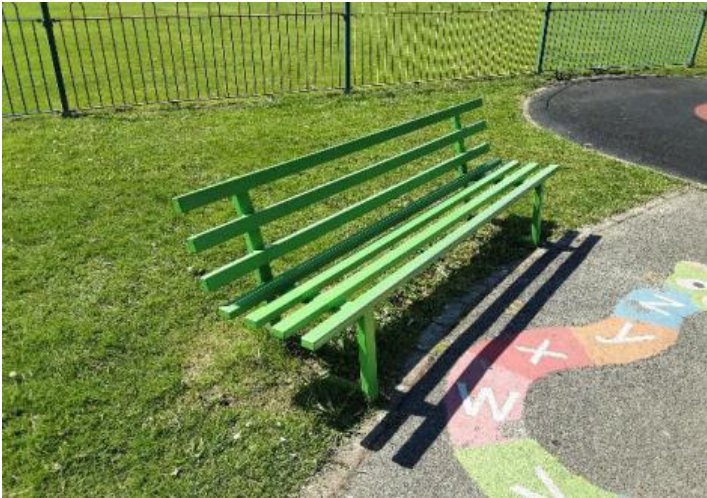
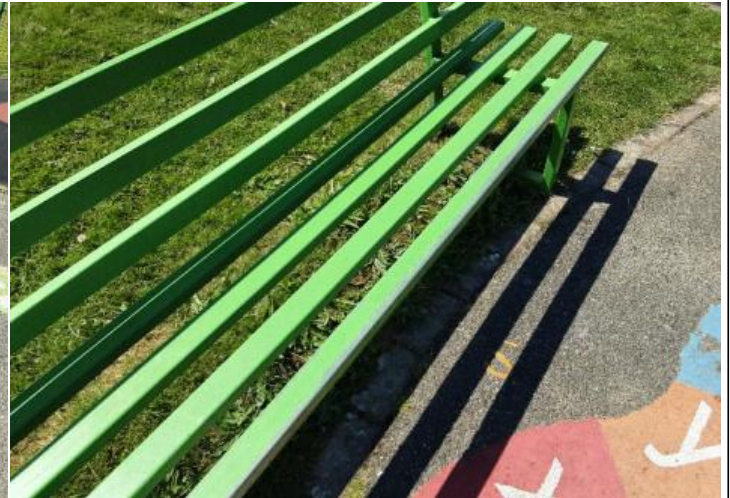
Item: Ancillary Items - Bench
Manufacturer: Wicksteed Playgrounds

Finding: The paint is flaking off the metalwork

Action: Rub down and re-paint

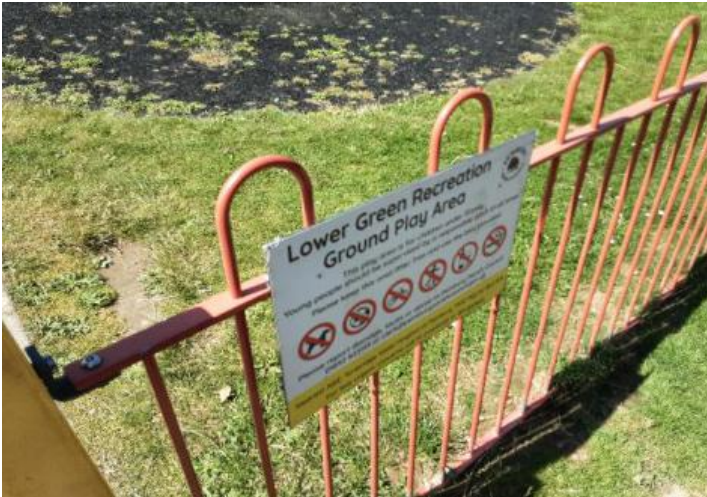
Item: Ancillary Items - Sign
Manufacturer: Owner/Operator

Finding: Cable ties have been used on the item and there are sharp projecting ends

Action: Remove if not required or replace with a more appropriate alternative fixing method if used as a fixing

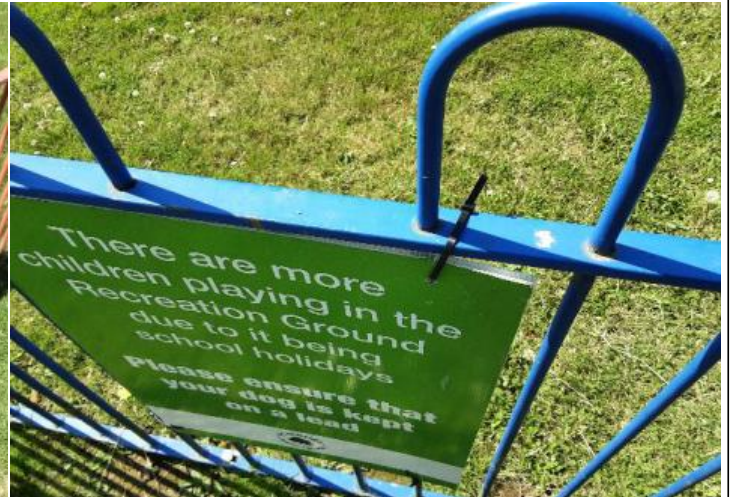
Risk Level: L - Low Risk
Surface: Grass

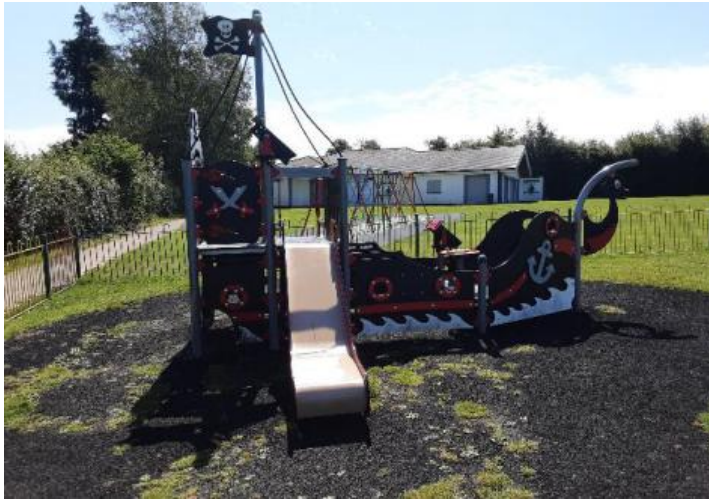
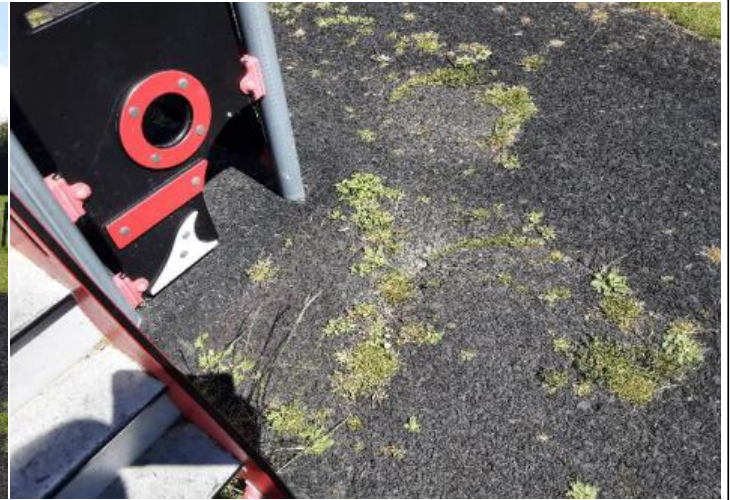
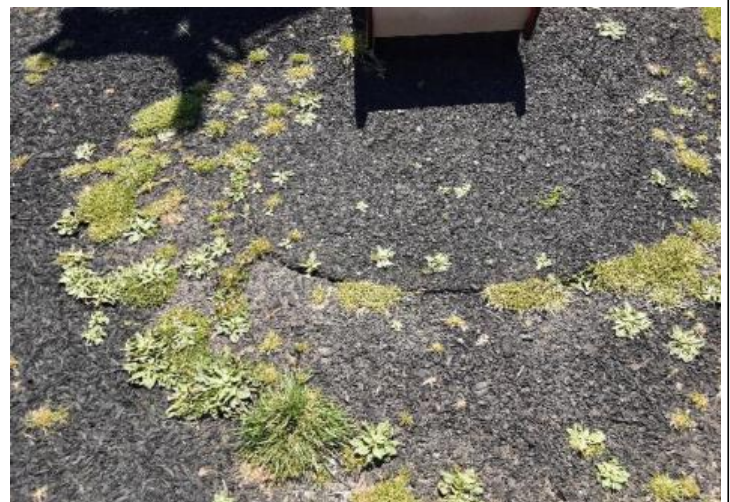
Risk Level: L - Low Risk
Surface: Wet Pour

Finding: There is moderate damage to the surface

Action: Repair the damaged areas of surfacing

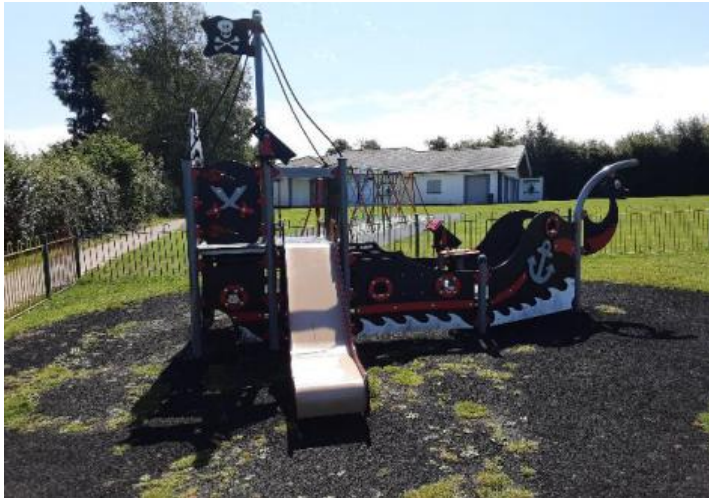
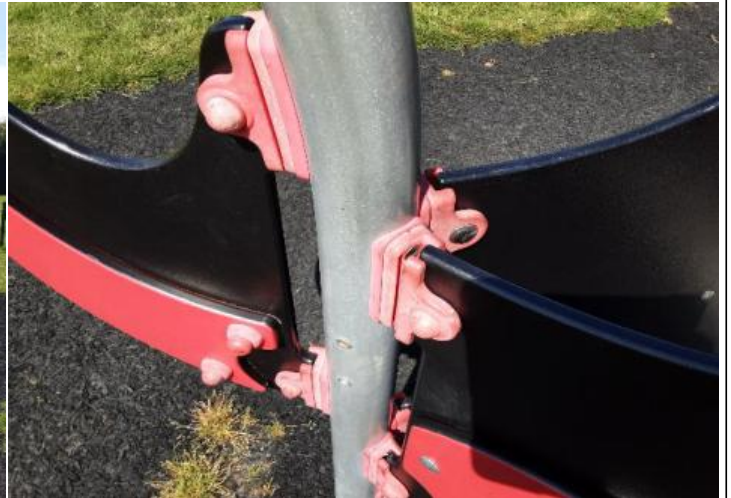
Risk Level: L - Low Risk
Surface: Wet Pour

Finding: A number of fixing(s) have worked loose

Action: Secure all loose fixings

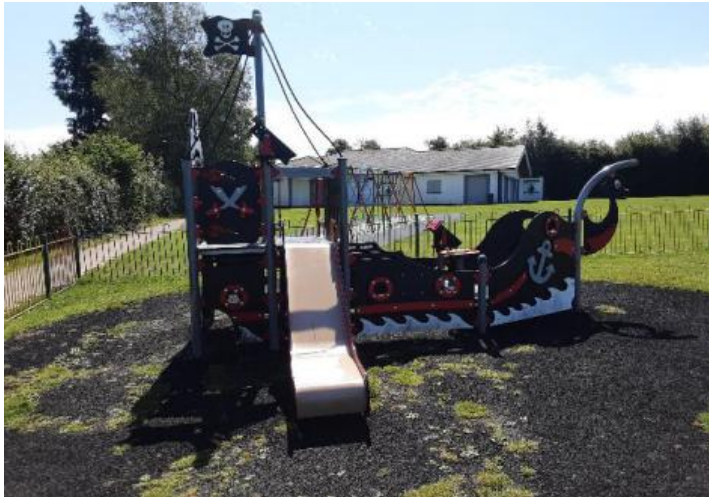
Item: Activity Equipment - Ship (Pirate)
Manufacturer: Mant Leisure

Finding: There is/are inserts missing

Action: Replace missing inserts

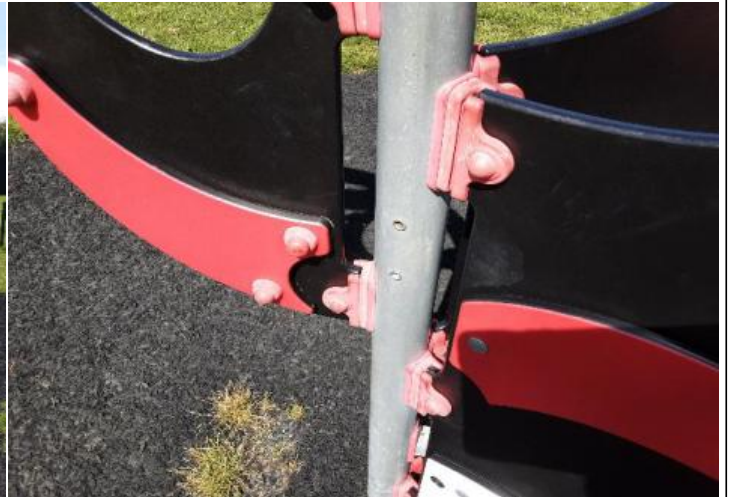
Risk Level: V - Very Low Risk
Surface: Wet Pour

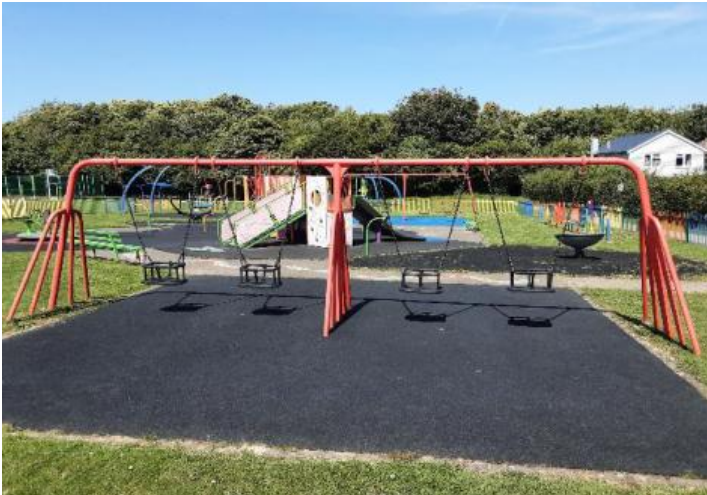
Item: Swings - 2 Bay 4 Seat (Cradle)
Manufacturer: Wicksteed Playgrounds

Finding: The chain openings are in excess of the 8.6mm as recommended by BS EN 1176 **Action:** Monitor - No remedial work recommended

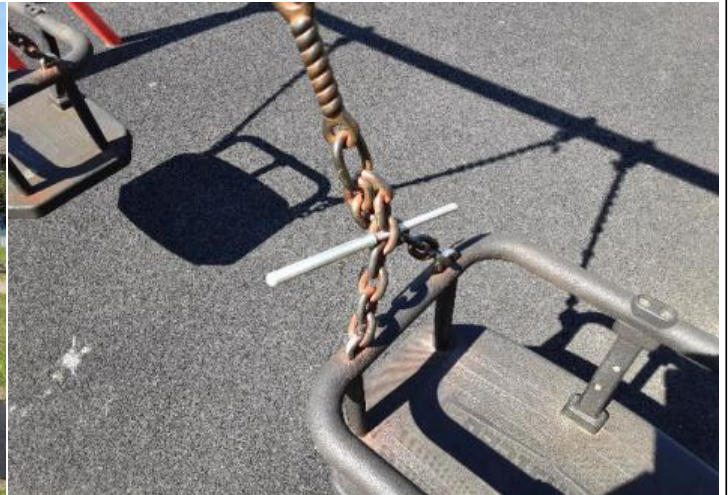
Risk Level: V - Very Low Risk
Surface: Wet Pour

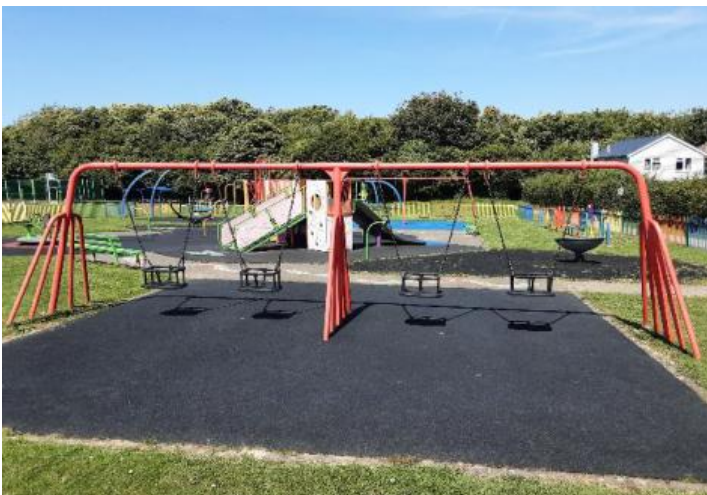
Item: Swings - 2 Bay 4 Seat (Cradle)
Manufacturer: Wicksteed Playgrounds

Finding: There is some notable evidence of chain wear **Action:** Monitor for any further deterioration and replace when 40% worn

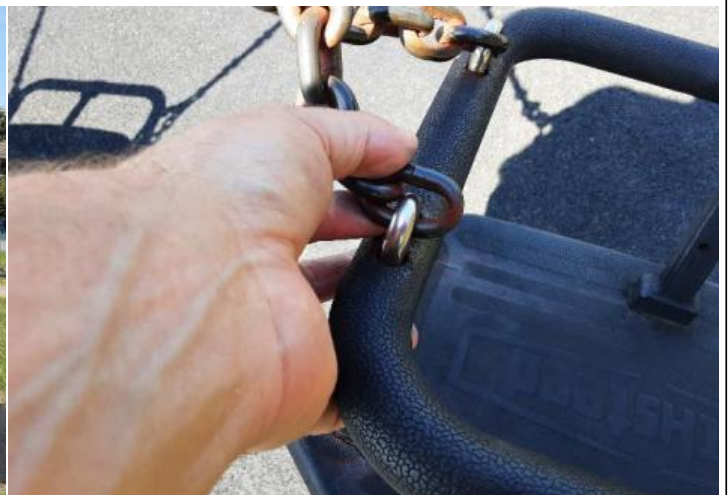
Risk Level: L - Low Risk
Surface: Wet Pour

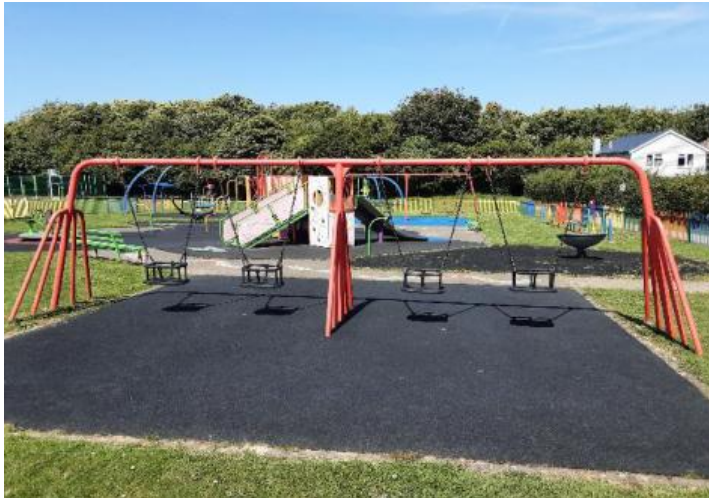
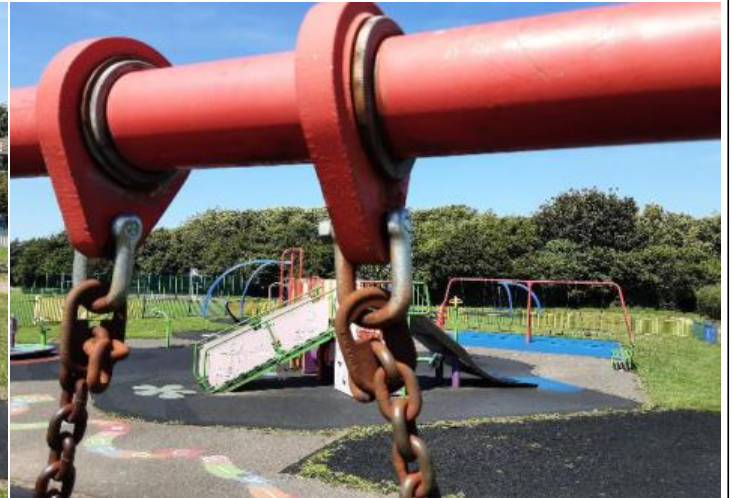
Risk Level: L - Low Risk
Surface: Wet Pour

Finding: There is some wear to the shackles.

Action: Monitor for any further deterioration and replace when 40% worn

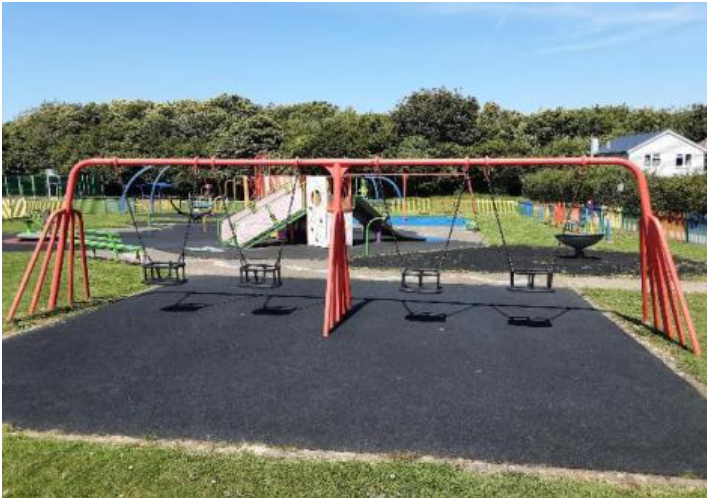
Item: Swings - 2 Bay 4 Seat (Cradle)
Manufacturer: Wicksteed Playgrounds

Finding: The seat has minor damage or wear

Action: Monitor for any further deterioration and replace as required

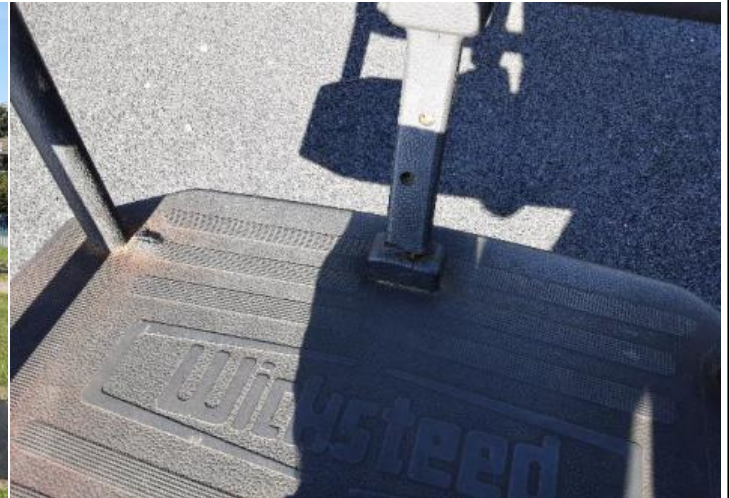
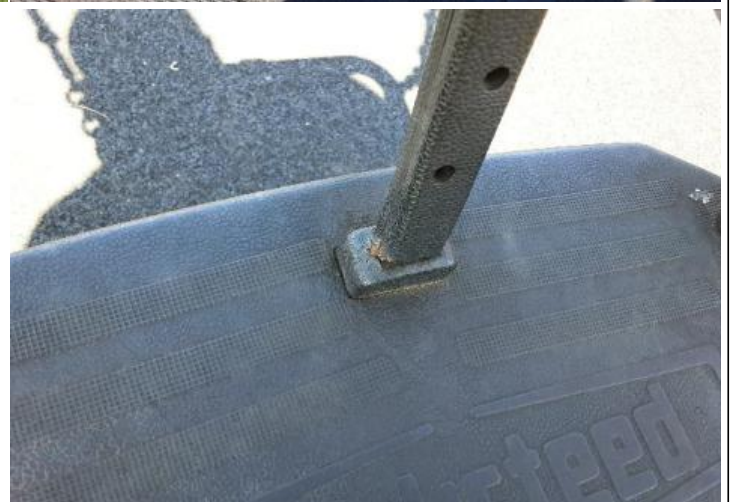
Risk Level: L - Low Risk
Surface: Wet Pour

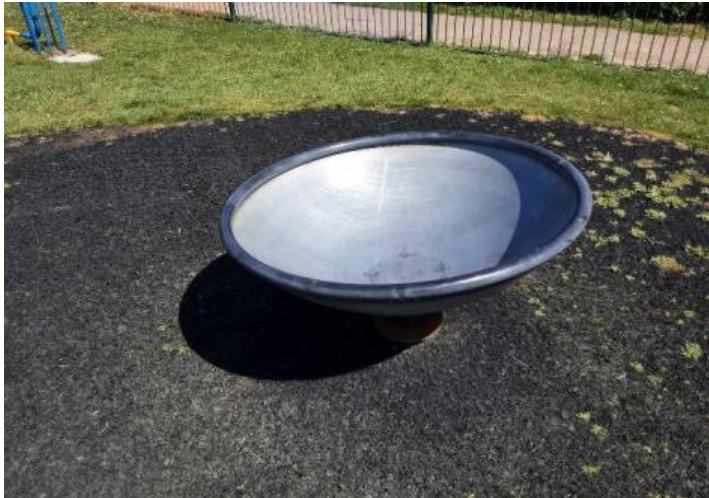
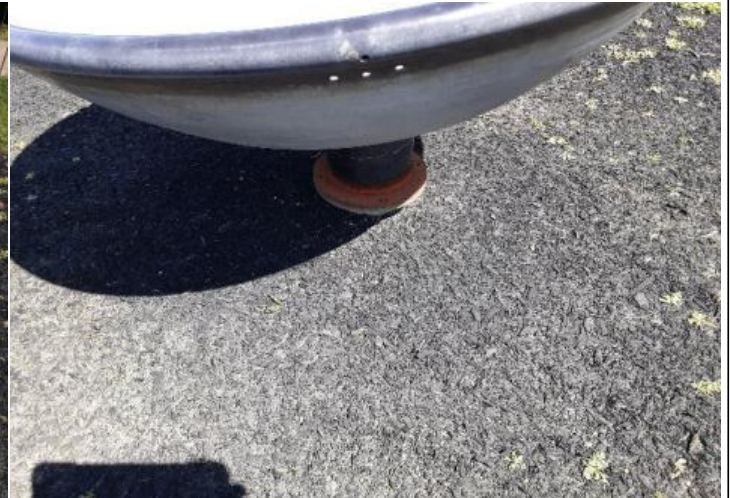
Risk Level: L - Low Risk
Surface: Wet Pour

Finding: The paintwork on this item has been damaged or worn exposing the metal underneath which is rusting / corroding

Action: Treat affected areas and repaint

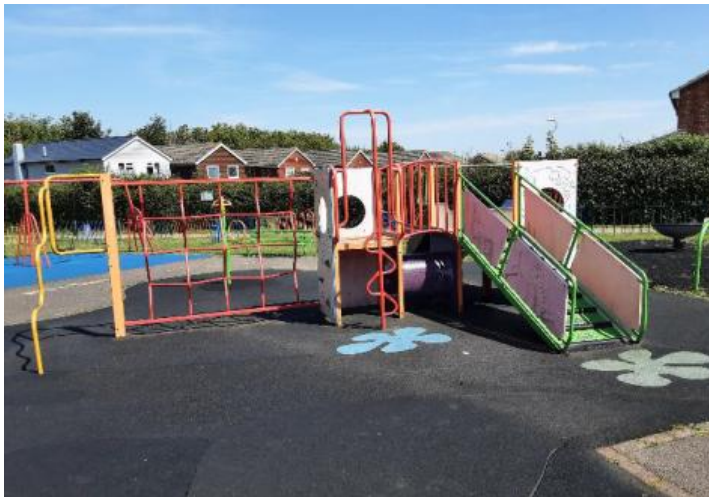
Item: Activity Equipment - Multi Play (Junior)
Manufacturer: Wicksteed Playgrounds

Finding: The surfacing dimensions are short and do not meet with the requirements of the current applicable standard

Action: Monitor - no remedial action recommended

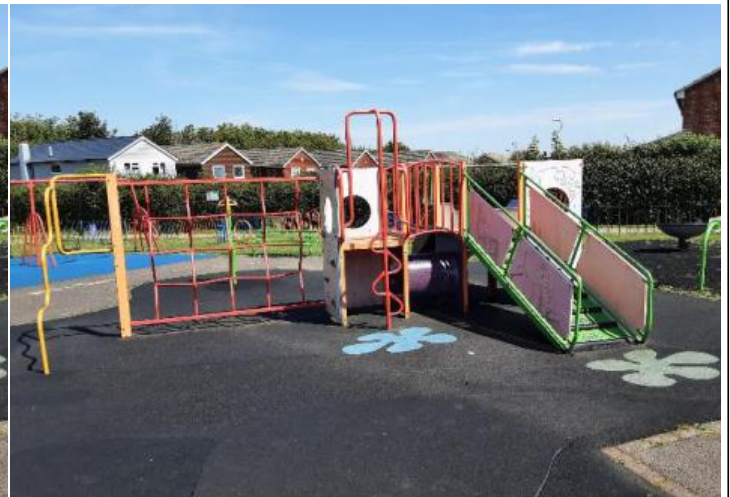
Risk Level: V - Very Low Risk
Surface: Wet Pour

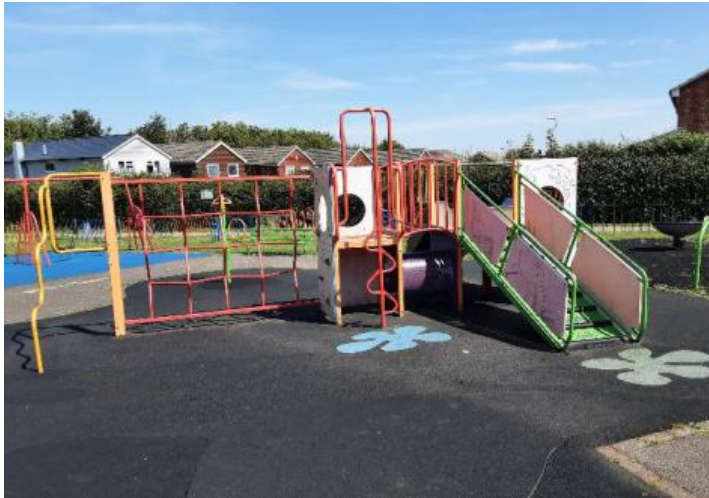
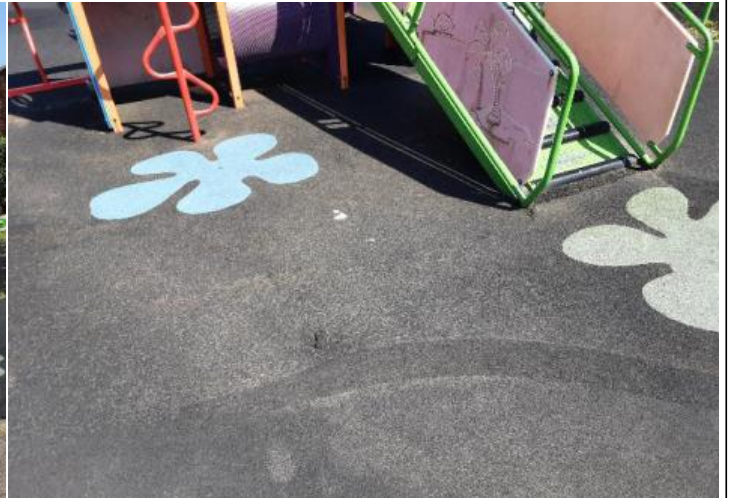
Risk Level: V - Very Low Risk
Surface: Wet Pour

Finding: There is some minor damage to the surface

Action: Monitor for any further deterioration and repair as required

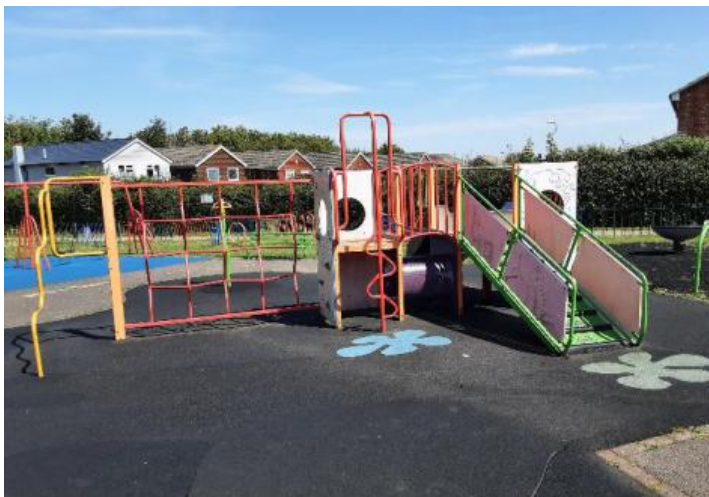
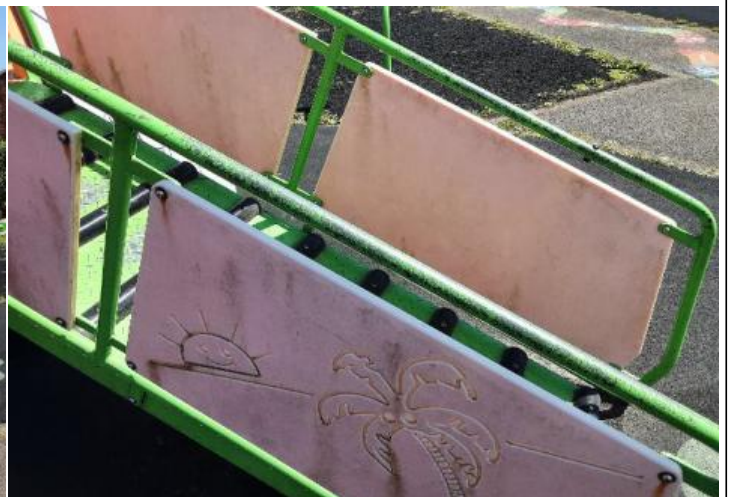
Item: Activity Equipment - Multi Play (Junior)
Manufacturer: Wicksteed Playgrounds

Finding: The paint is flaking off the metalwork

Action: Rub down and re-paint

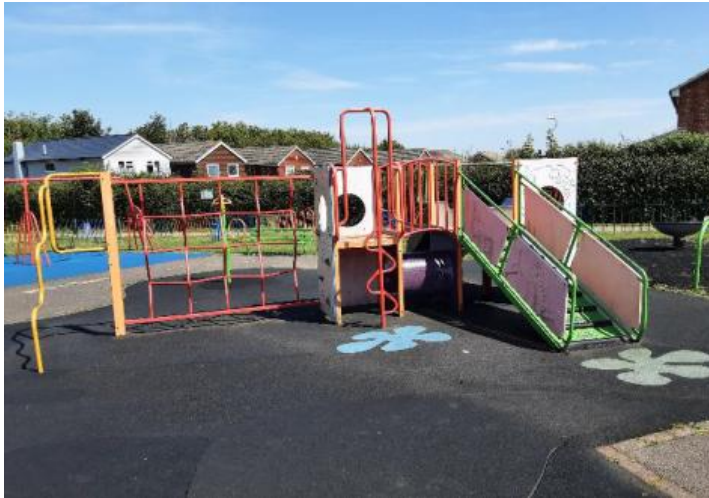
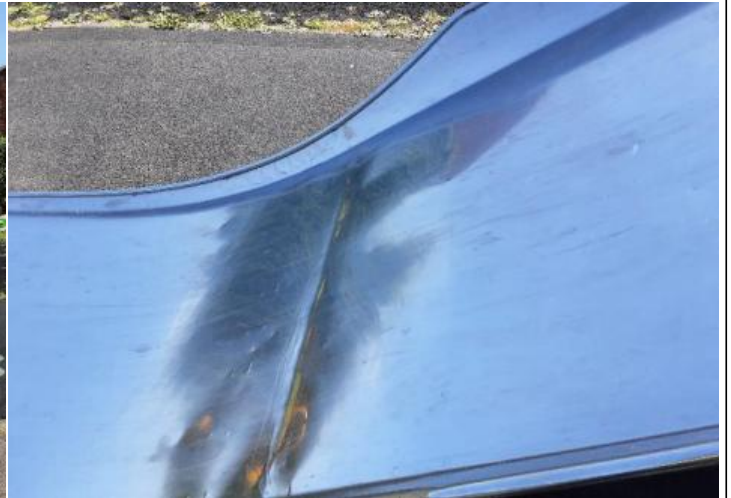
Risk Level: V - Very Low Risk
Surface: Wet Pour

Finding: There are a number of dents in the slide surface

Action: Monitor for any further deterioration and repair as required

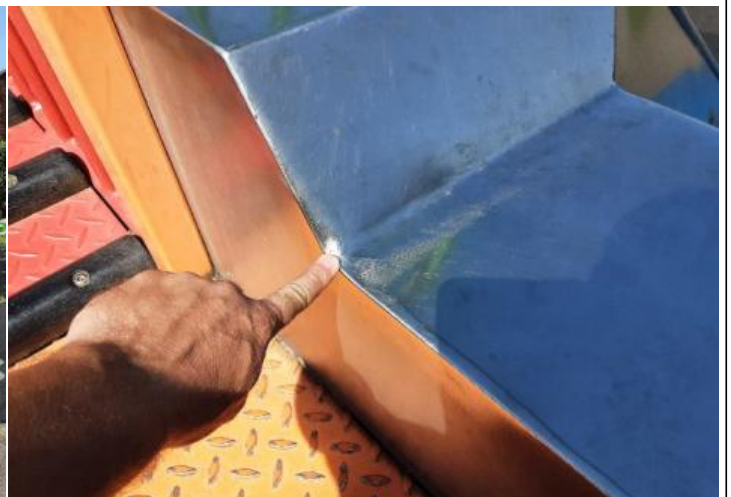
Risk Level: L - Low Risk
Surface: Wet Pour

Finding: There is a split in the slide surface

Action: Repair slide
