To all Members of the Open Spaces Committee

You are hereby summoned to attend a meeting of the **OPEN SPACES COMMITTEE** at the Parish Office, Lower Green Recreation Ground, Pembury, TN2 4DZ on **Monday 30th September** at **3:00pm**.

8. **LOWER GREEN RECREATION GROUND.**
 - a. To receive RoSPA annual inspection report for play equipment and note recommendations.
 - b. To consider the option for football club to be able to store new goals on wheels in the outside section of the goal store area at the Pavilion.
 - c. To report on the meeting at Hilbert Park and consider next steps.
 - d. To consider recreation ground consultation report and agree next steps.
 - e. To consider improvements and new play equipment funded by section 106 and agree next steps.

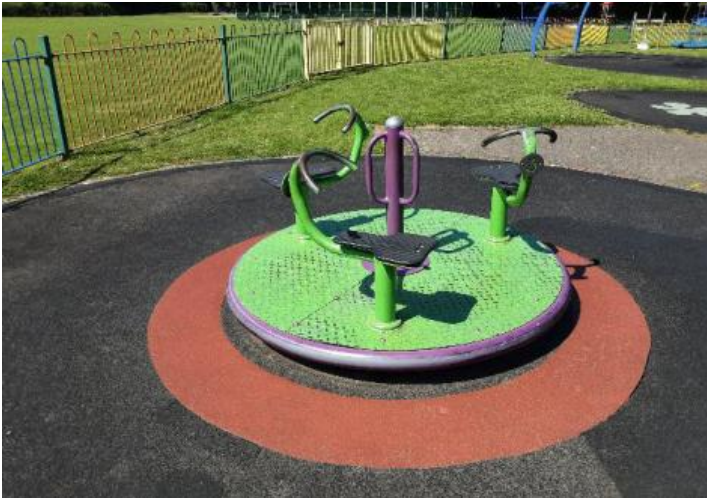
Item: Rotor Play - Roundabout
Manufacturer: Wicksteed Playgrounds

Finding: The paintwork on this item has been damaged or worn exposing the metal underneath which is rusting / corroding

Action: Treat affected areas and repaint

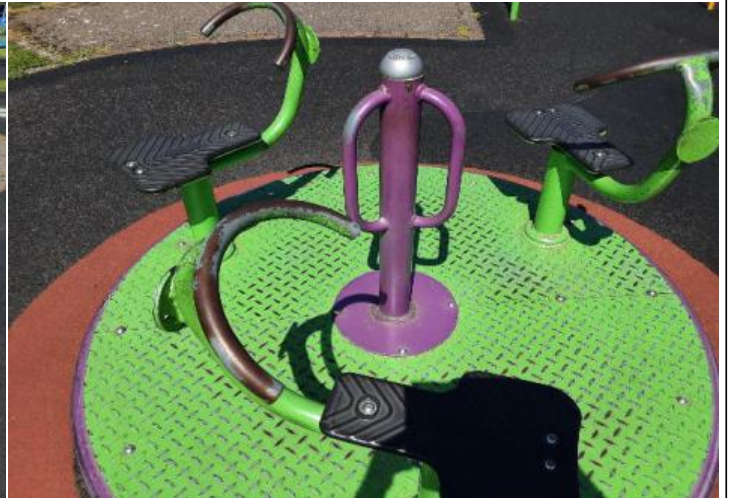
Risk Level: L - Low Risk
Surface: Wet Pour

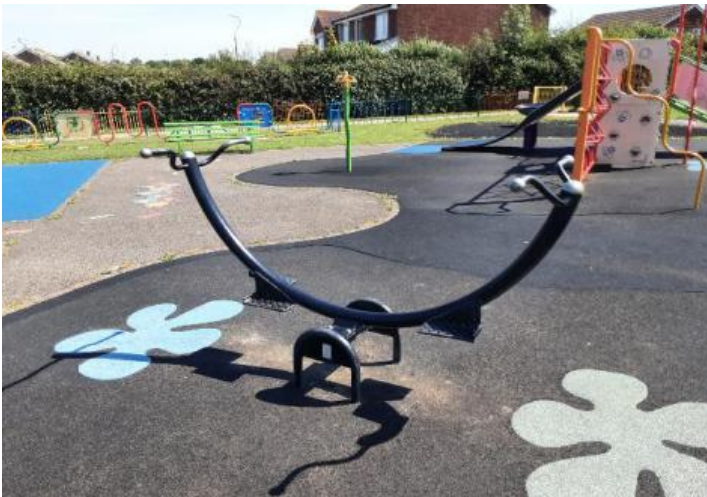
Item: Rocking Equipment - Stand up SeeSaw
Manufacturer: Wicksteed Playgrounds

Finding: The paintwork on this item has been damaged or worn exposing the metal underneath which is rusting / corroding

Action: Treat affected areas and repaint

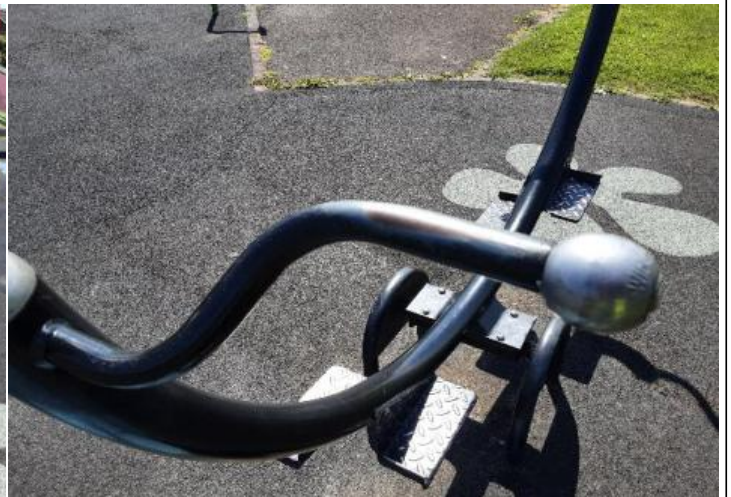
Risk Level: L - Low Risk
Surface: Wet Pour

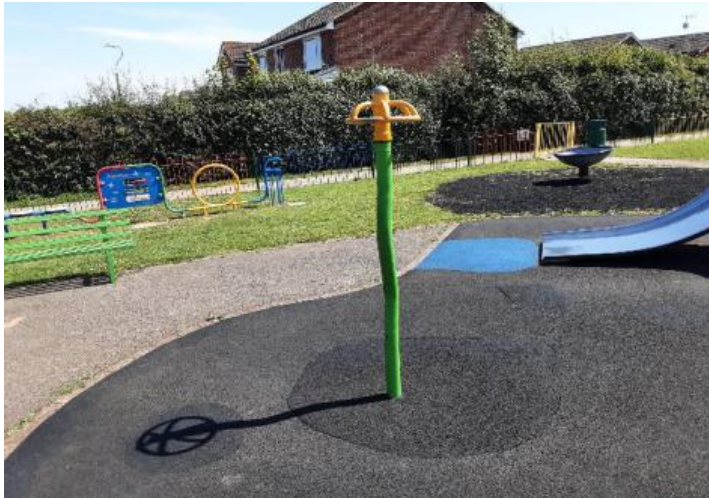
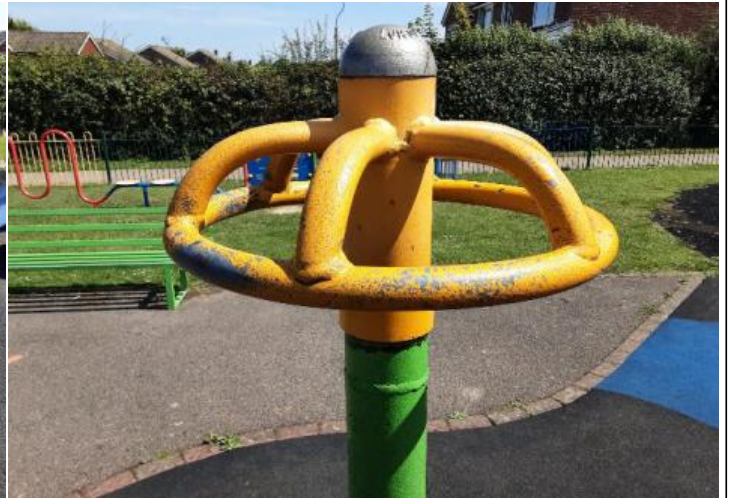
Risk Level: L - Low Risk
Surface: Wet Pour

Finding: The bearing is showing signs of wear

Action: Monitor for any further deterioration and replace as required

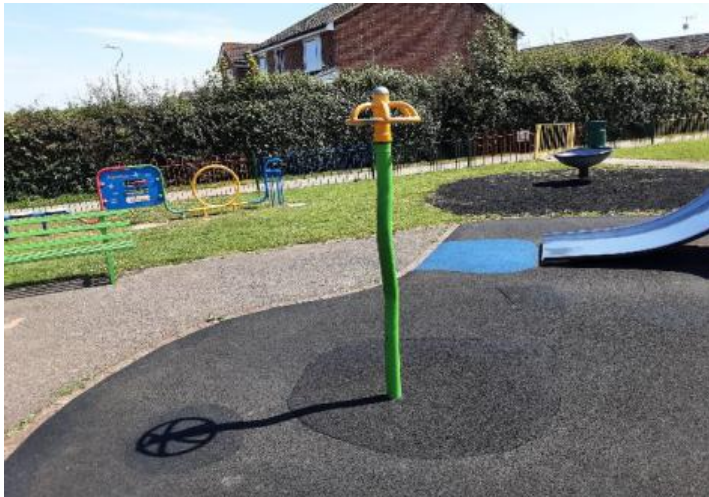
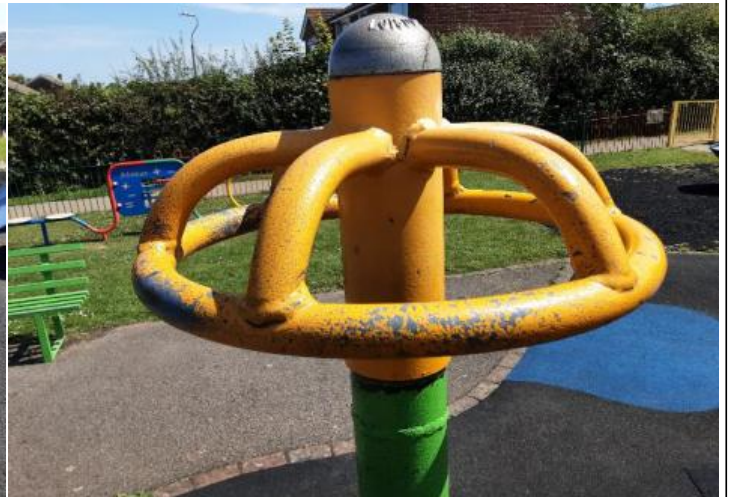
Item: Rotor Play - Overhead Rotator
Manufacturer: Wicksteed Playgrounds

Finding: The paint is flaking off the metalwork

Action: Rub down and re-paint

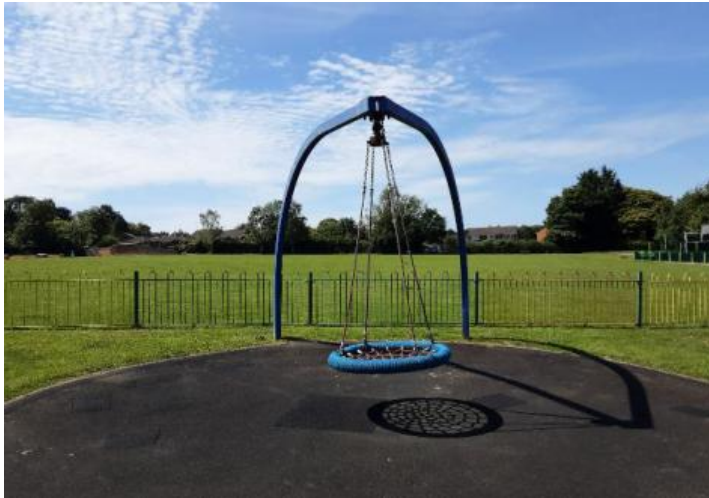
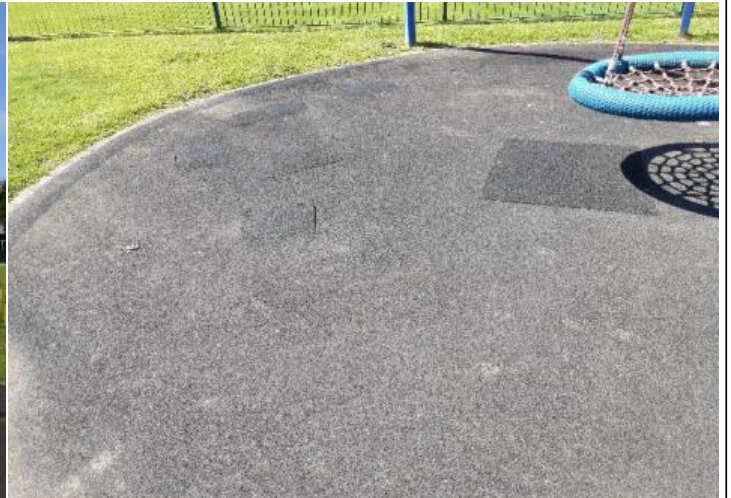
Risk Level: L - Low Risk
Surface: Wet Pour

Finding: The safety surface around the area is beginning to wear

Action: Monitor for any further deterioration and repair as required

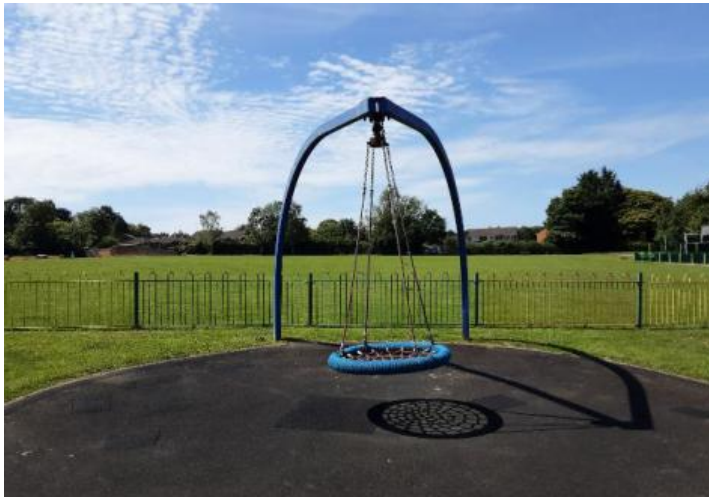
Item: Swings - Single Point Swing - Type 3
Manufacturer: Wicksteed Playgrounds

Finding: The surfacing dimensions are short and do not meet with the requirements of the current applicable standard

Action: Monitor - no remedial action recommended

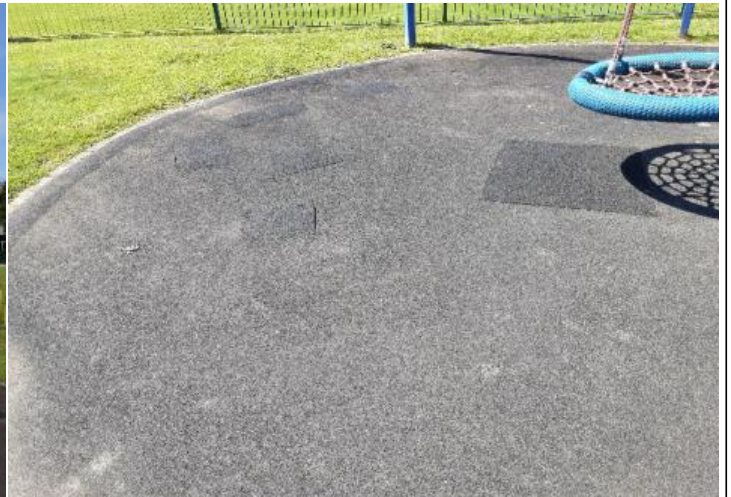
Risk Level: V - Very Low Risk
Surface: Wet Pour

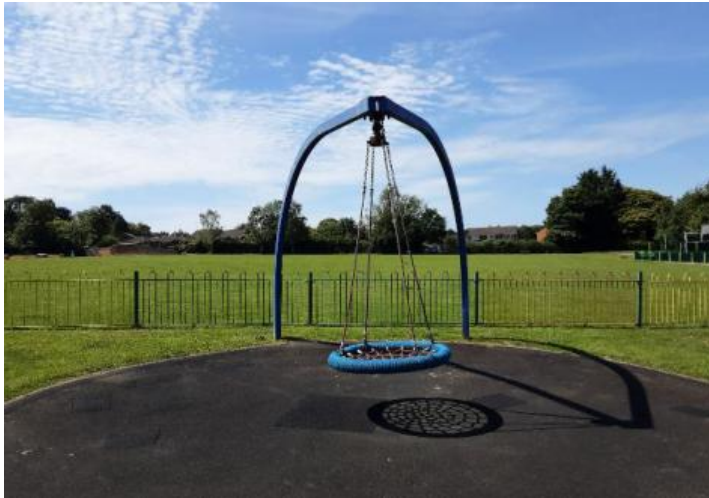
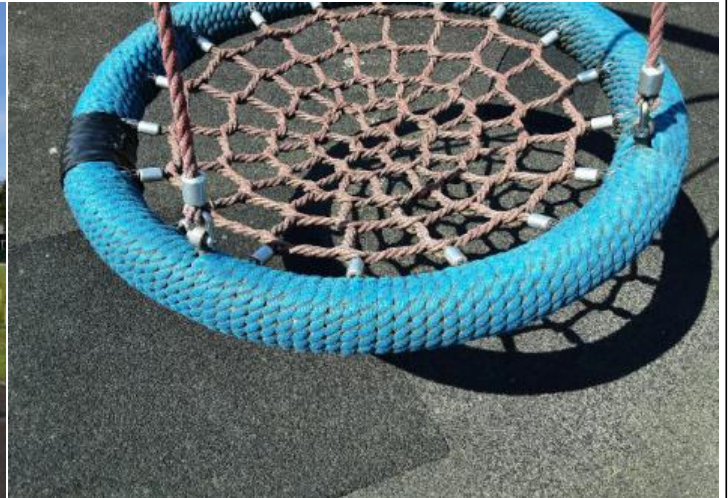
Risk Level: L - Low Risk
Surface: Wet Pour

Finding: The seat has minor damage or wear

Action: Monitor for any further deterioration and replace as required

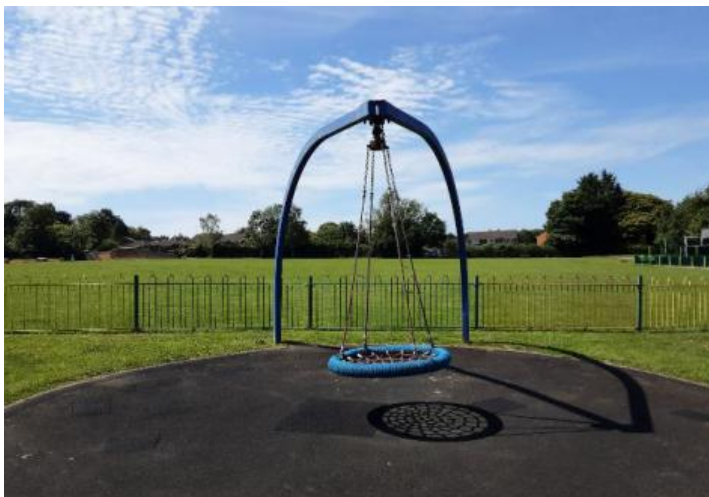
Item: Swings - Single Point Swing - Type 3
Manufacturer: Wicksteed Playgrounds

Finding: The manufacturer of this product makes a recommendation that the universal swing joint should be replaced at 5 year intervals. Usually there is an ID tag present stating the date the joint was last replaced, however there is no tag present on this joint which would indicate that it has not been replaced recently

Action: Consult with manufacturer for replacement part

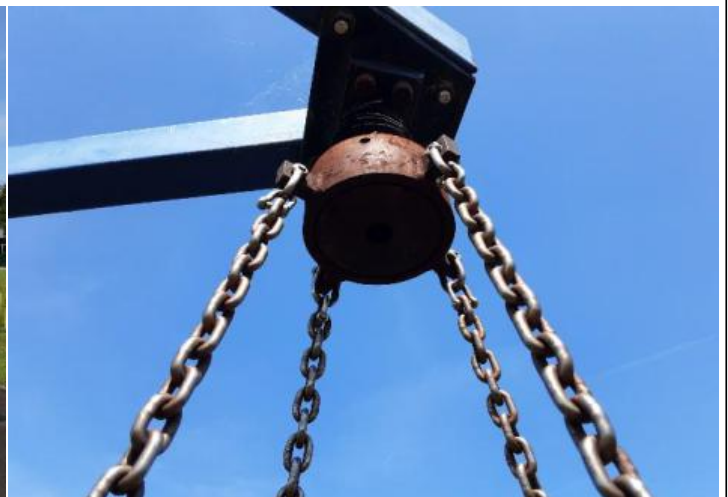
Risk Level: L - Low Risk
Surface: Wet Pour

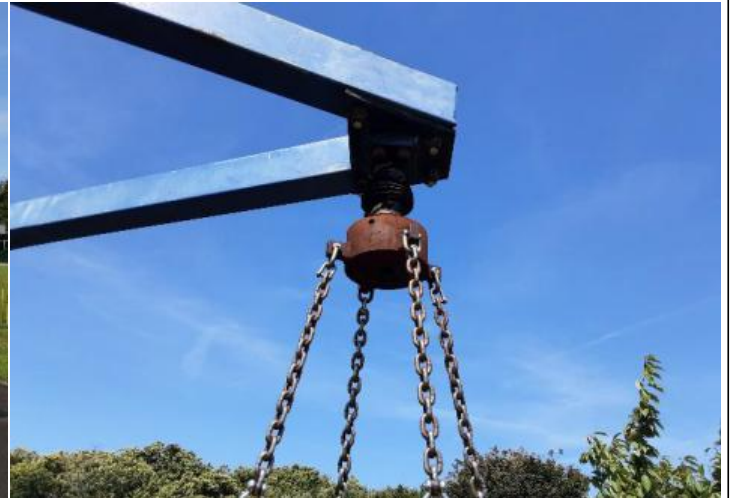
Item: Swings - Single Point Swing - Type 3
Manufacturer: Wicksteed Playgrounds
Risk Level: L - Low Risk
Surface: Wet Pour

Finding: There is some wear to the shackles.
Action: Monitor for any further deterioration and replace when 40% worn

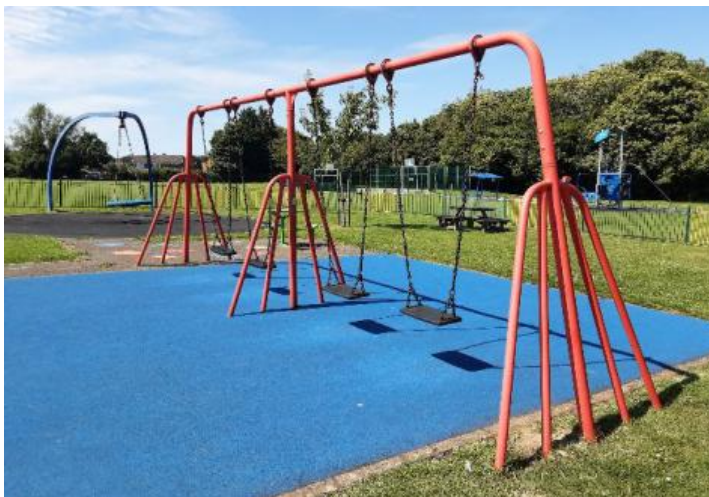
Item: Swings - 2 Bay 4 Seat (Flat)
Manufacturer: Wicksteed Playgrounds
Risk Level: V - Very Low Risk
Surface: Wet Pour

Finding: The chain openings are in excess of the 8.6mm as recommended by BS EN 1176
Action: Monitor - No remedial work recommended

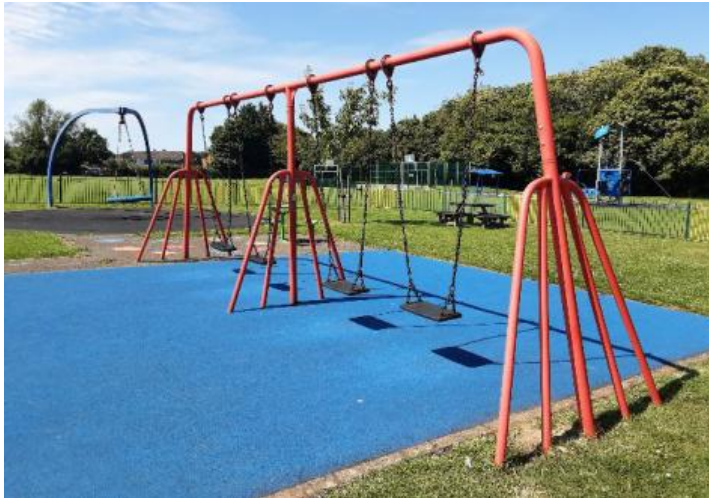
Item: Swings - 2 Bay 4 Seat (Flat)
Manufacturer: Wicksteed Playgrounds

Finding: The seat has minor damage or wear

Action: Monitor for any further deterioration and replace as required

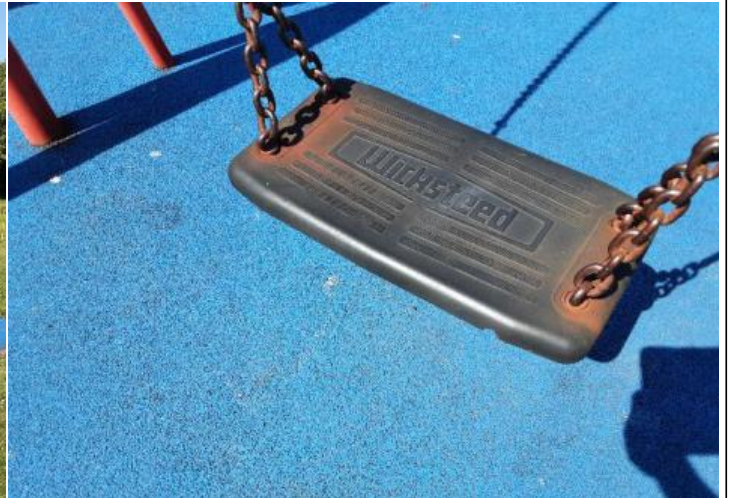
Risk Level: L - Low Risk
Surface: Wet Pour

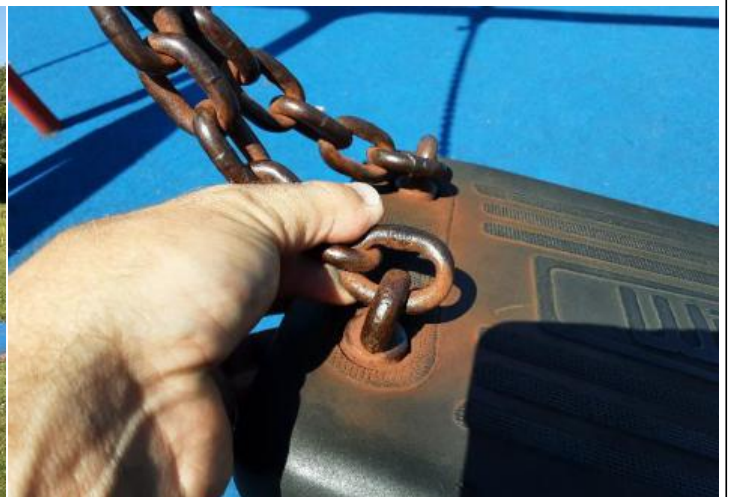
Risk Level: L - Low Risk
Surface: Wet Pour

Finding: There is some notable evidence of chain wear

Action: Monitor for any further deterioration and replace when 40% worn

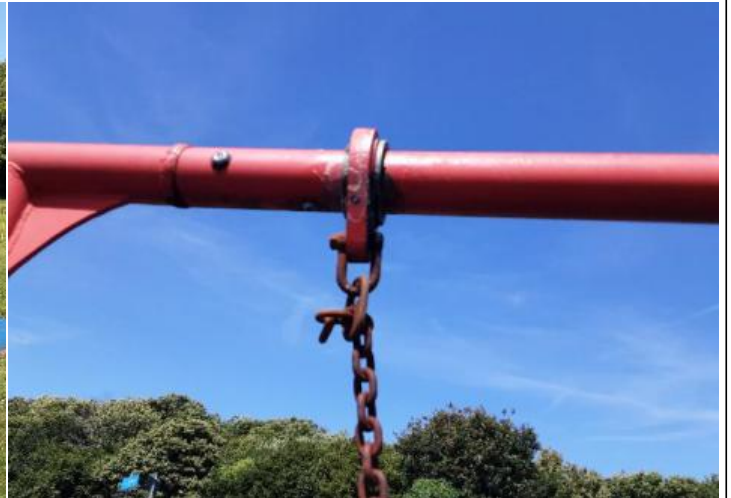
Risk Level: L - Low Risk
Surface: Wet Pour

Finding: There is some wear to the shackles.

Action: Monitor for any further deterioration and replace when 40% worn

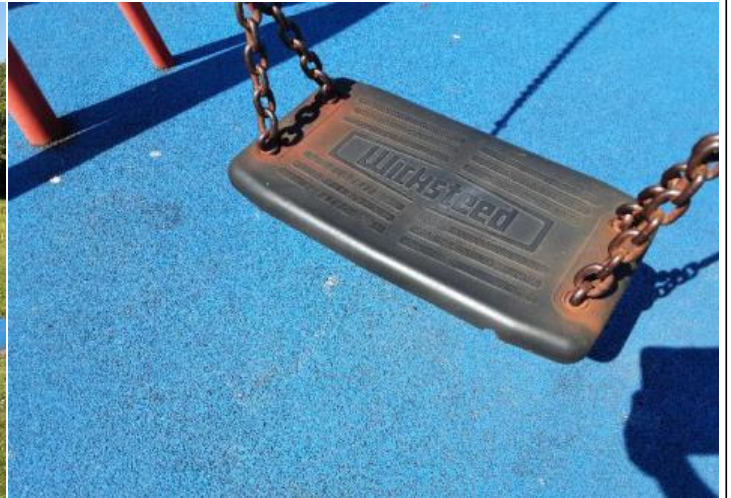
Risk Level: L - Low Risk
Surface: Wet Pour

Finding: The swing seat connectors have some wear present

Action: Monitor for further deterioration and replace when 40% worn

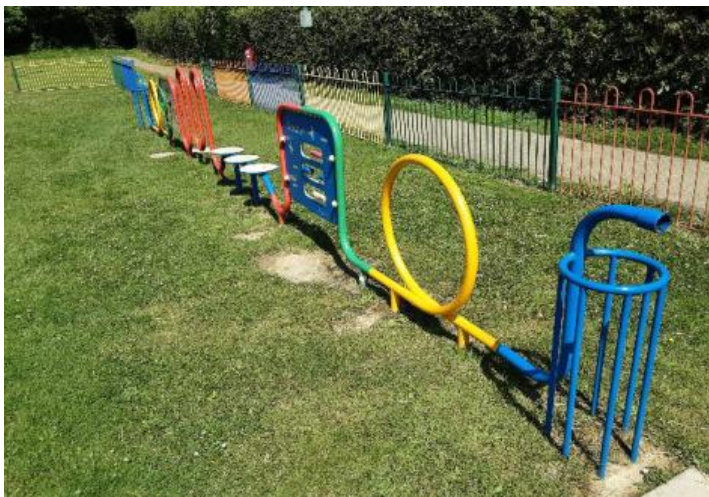
Item: Activity Equipment - Activity Trail
Manufacturer: Wicksteed Playgrounds

Finding: The surface has eroded in some areas and may be slippery in wet conditions

Action: Reinstate the surface

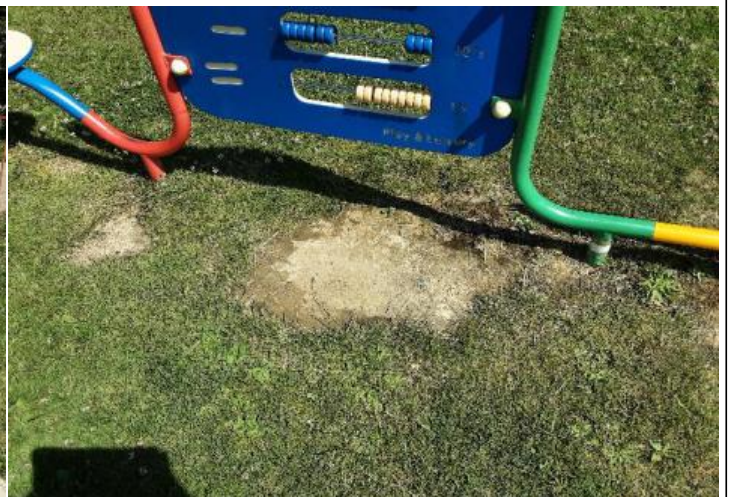
Risk Level: L - Low Risk
Surface: Grass

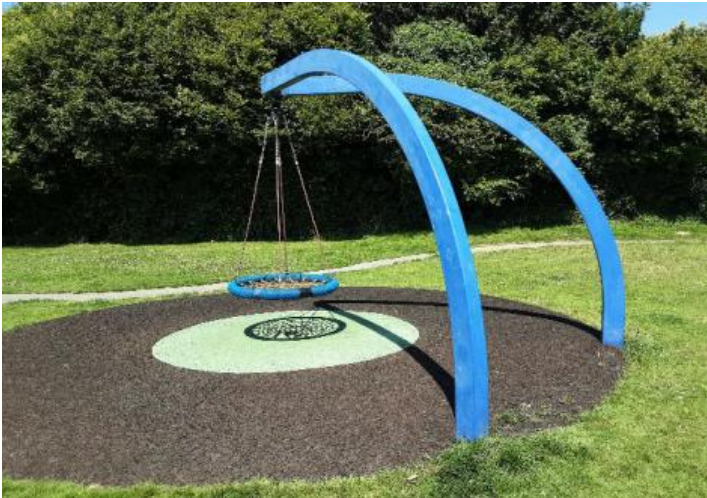
Item: Swings - Single Point Swing - Type 3
Manufacturer: Wicksteed Playgrounds

Finding: There is some evidence of fire damage to the seat creating hard / sharp areas
Action: Replace the seat

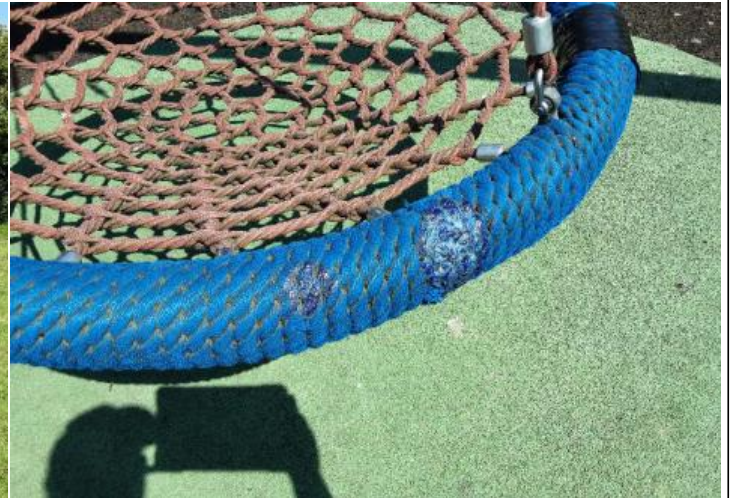
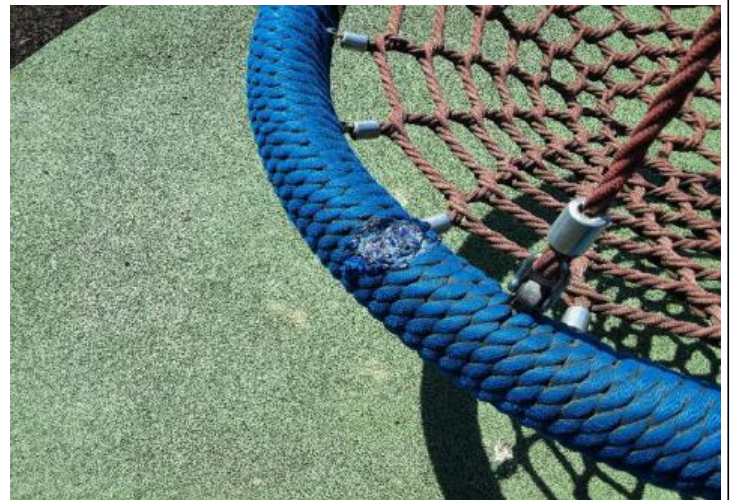
Risk Level: L - Low Risk
Surface: Bonded Rubber Mulch

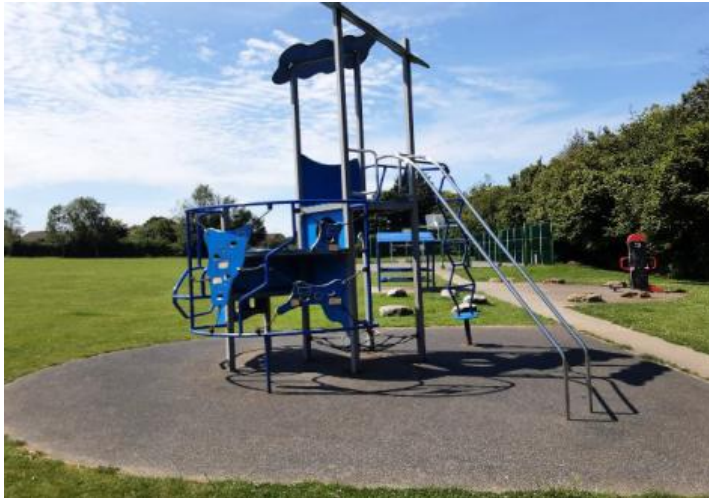
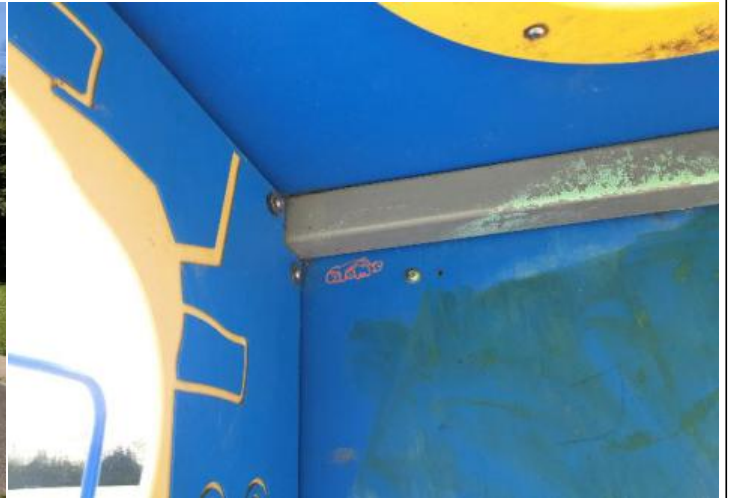
Item: Activity Equipment - Multi Play (Senior)
Manufacturer: Wicksteed Playgrounds

Finding: There is some graffiti present

Action: Remove the graffiti

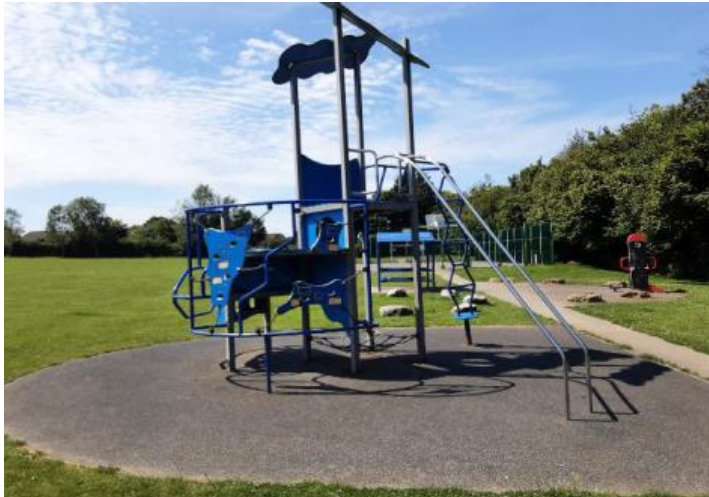
Item: Activity Equipment - Multi Play (Senior)
Manufacturer: Wicksteed Playgrounds

Finding: The chain openings are in excess of the 8.6mm as recommended by BS EN 1176

Action: Monitor - No remedial work recommended

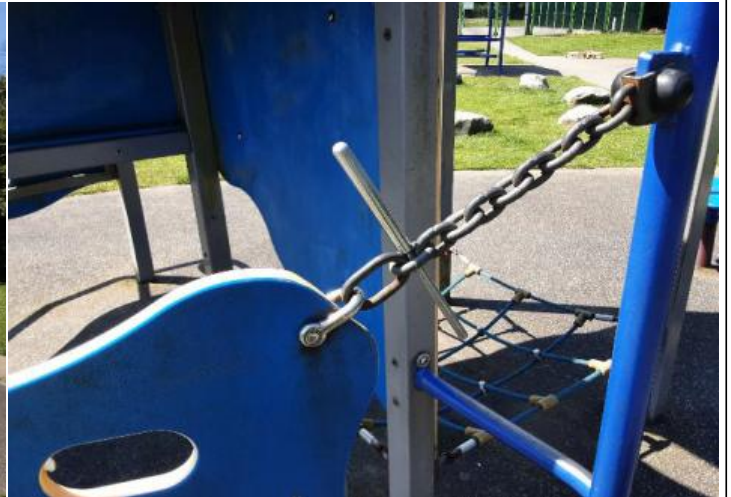
Risk Level: V - Very Low Risk
Surface: Wet Pour

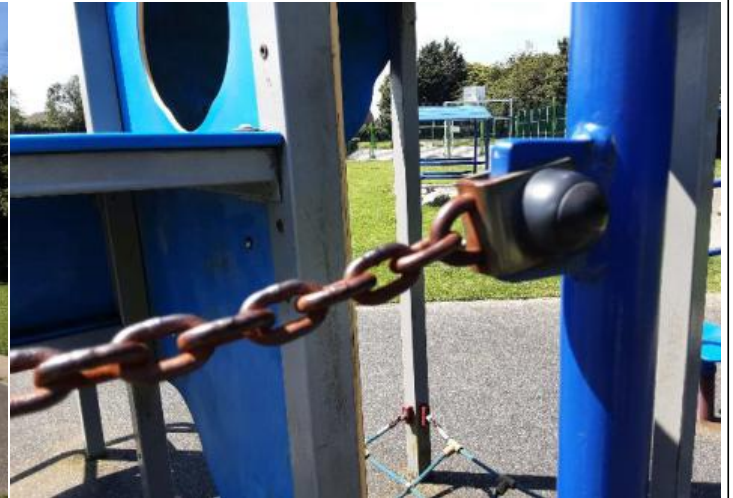
Risk Level: L - Low Risk
Surface: Wet Pour

Finding: There is some notable evidence of chain wear

Action: Monitor for any further deterioration and replace when 40% worn

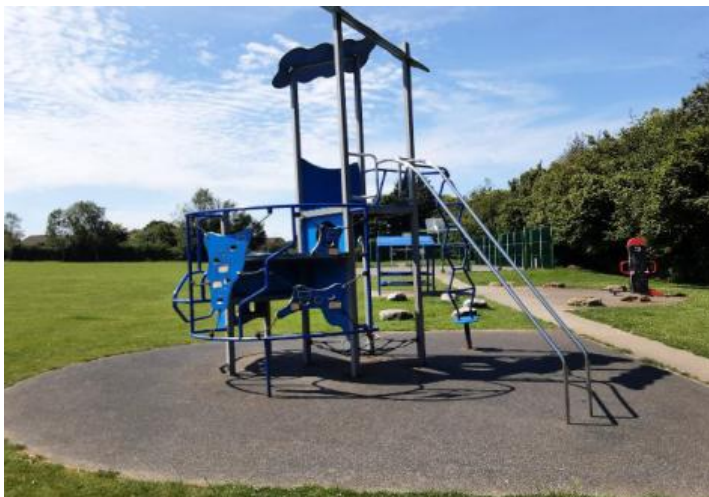
Item: Activity Equipment - Multi Play (Senior)
Manufacturer: Wicksteed Playgrounds

Finding: There are falls in excess of 1000mm between adjacent platforms on the structure, in contravention of the recommendations set out in BS EN 1176 Part 1

Action: Monitor - No remedial work recommended

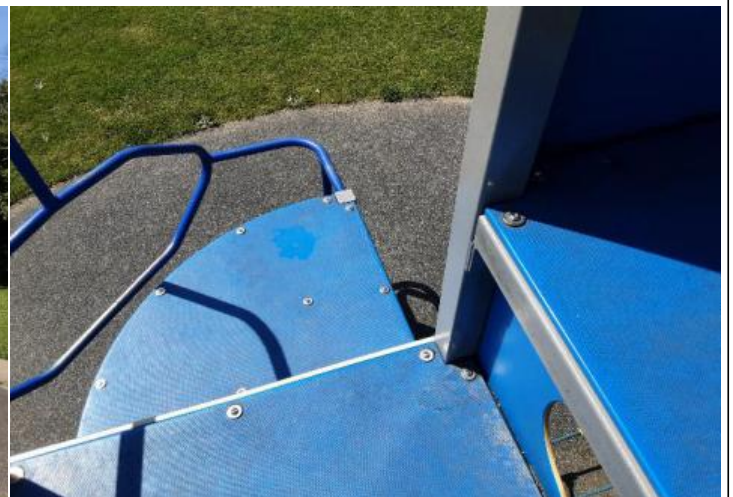
Risk Level: L - Low Risk
Surface: Wet Pour

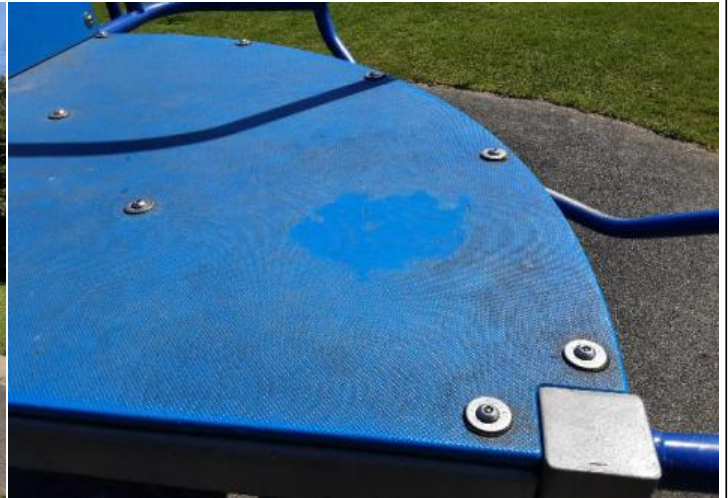
Risk Level: L - Low Risk
Surface: Wet Pour

Finding: The item has been damaged

Action: Monitor for any further deterioration and replace as required

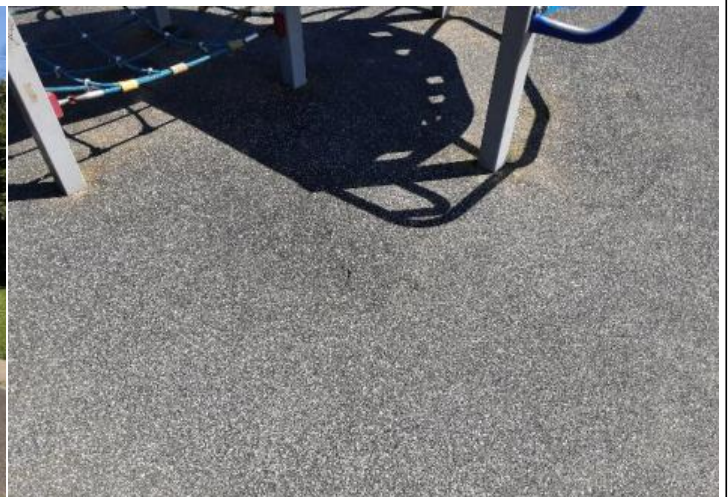
Risk Level: V - Very Low Risk
Surface: Wet Pour

Finding: There is some minor damage to the surface

Action: Monitor for any further deterioration and repair as required

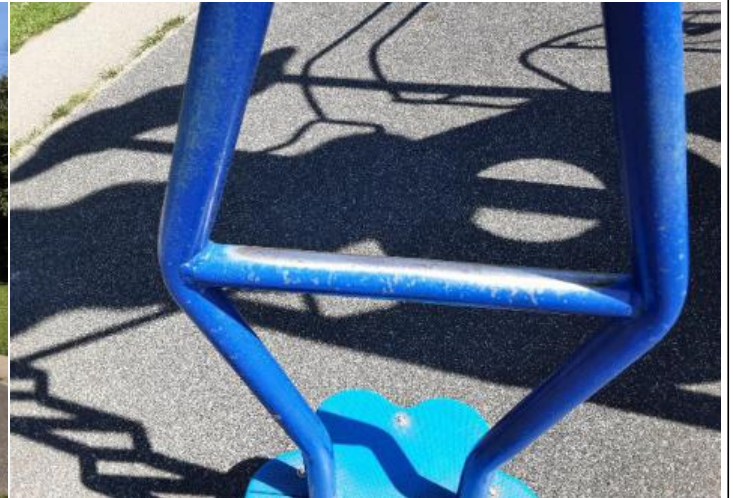
Risk Level: L - Low Risk
Surface: Wet Pour

Finding: The paintwork on this item has been damaged or worn exposing the metal underneath which is rusting / corroding

Action: Treat affected areas and repaint

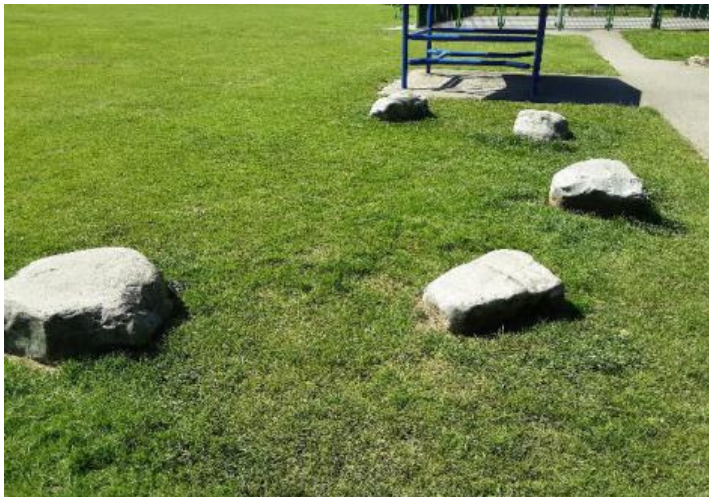
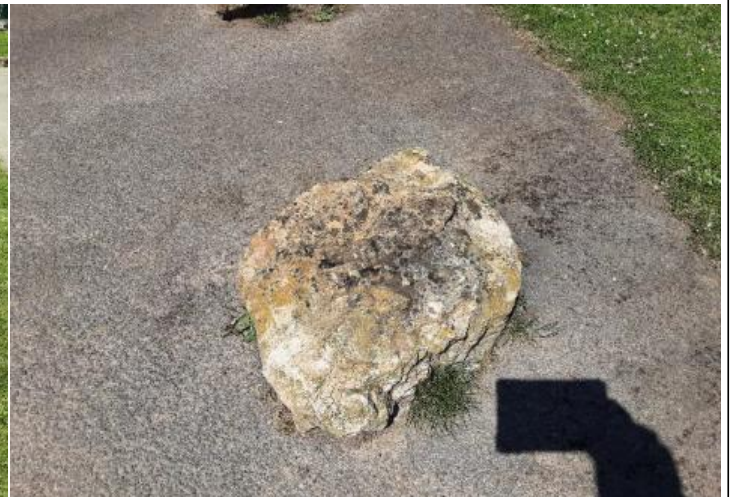
Item: Ancillary Items - Boulders
Manufacturer: Natural Feature

Finding: The rocks and/or boulders have moss/algae growth apparent

Action: Clean and maintain

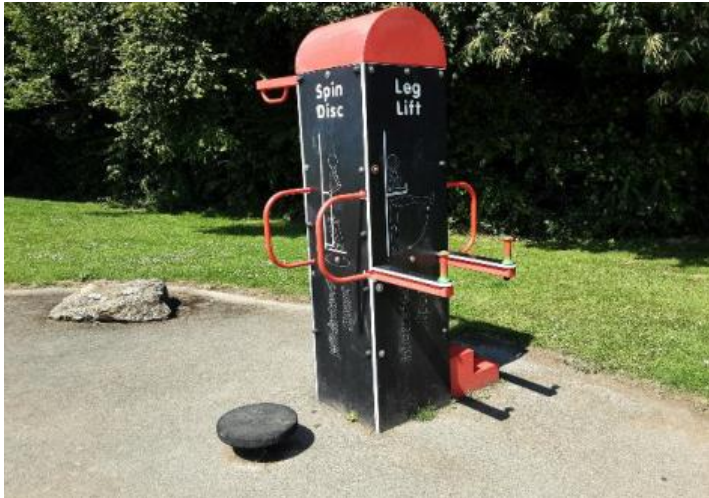
Item: Outdoor Fitness Equipment - Fit Point
Manufacturer: Wicksteed Playgrounds
Risk Level: L - Low Risk
Surface: Bitmac

Finding: The deflection of the rotating user station exceeds the maximum 105 degrees required by BS EN 16630
Action: Monitor - No remedial work recommended

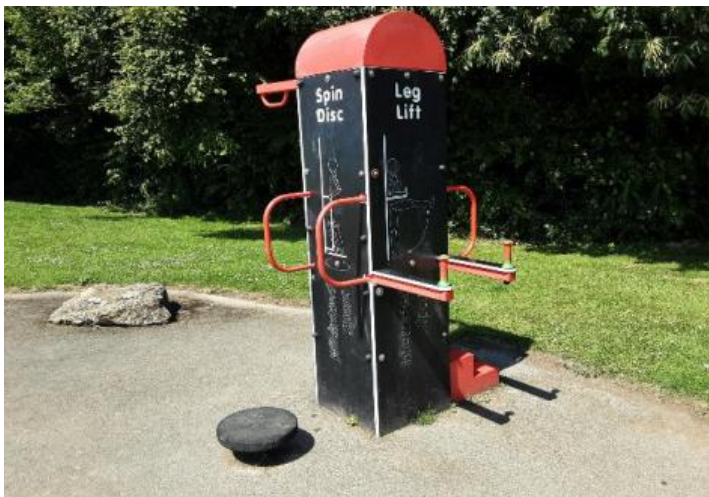
Item: Outdoor Fitness Equipment - Fit Point
Manufacturer: Wicksteed Playgrounds
Risk Level: L - Low Risk
Surface: Bitmac

Finding: The rotating user station is not appropriately marked with a guideline of user direction and/or the original position as required by BS EN 16630
Action: Monitor - No remedial work recommended

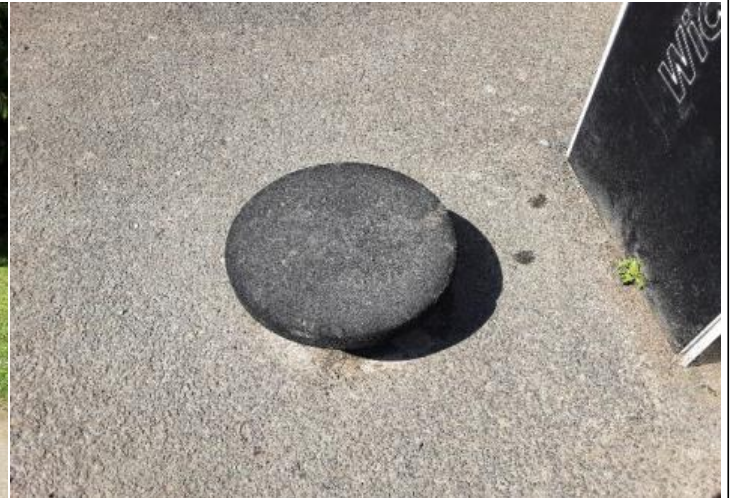
Risk Level: L - Low Risk
Surface: Bitmac

Finding: The item has been damaged

Action: Monitor for any further deterioration and replace as required

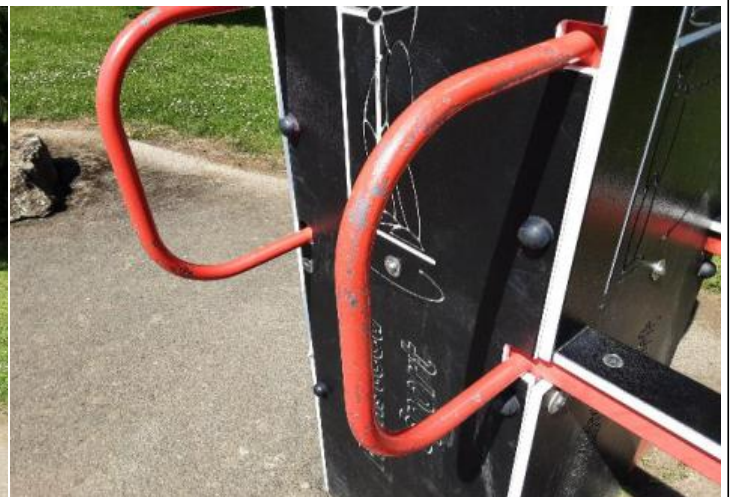
Item: Outdoor Fitness Equipment - Fit Point
Manufacturer: Wicksteed Playgrounds

Finding: The paint is flaking off the metalwork

Action: Rub down and re-paint

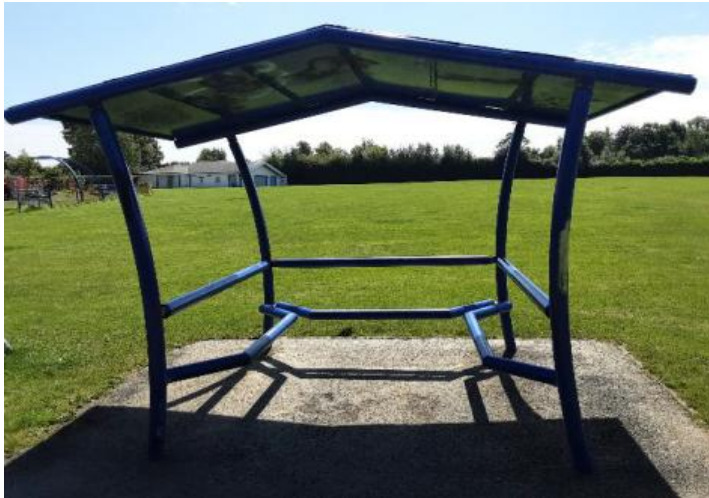
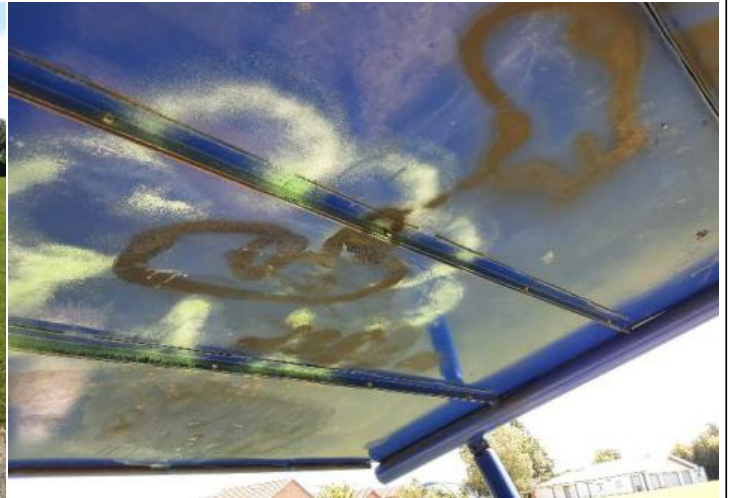
Item: Ancillary Items - Shelter
Manufacturer: Wicksteed Playgrounds

Finding: There is some graffiti present

Action: Remove the graffiti

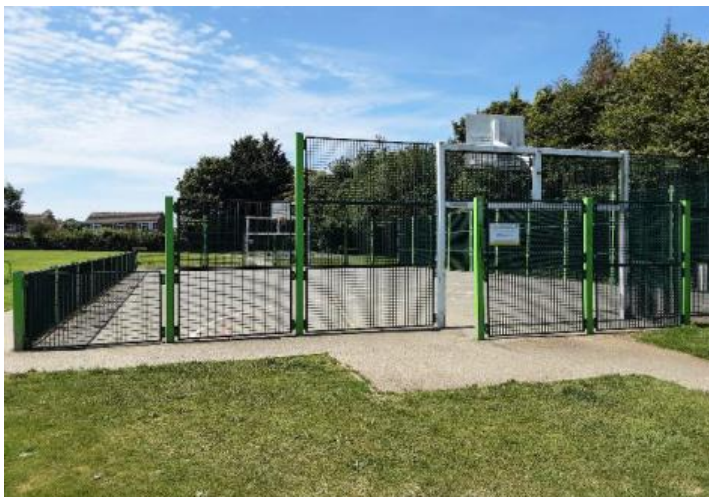
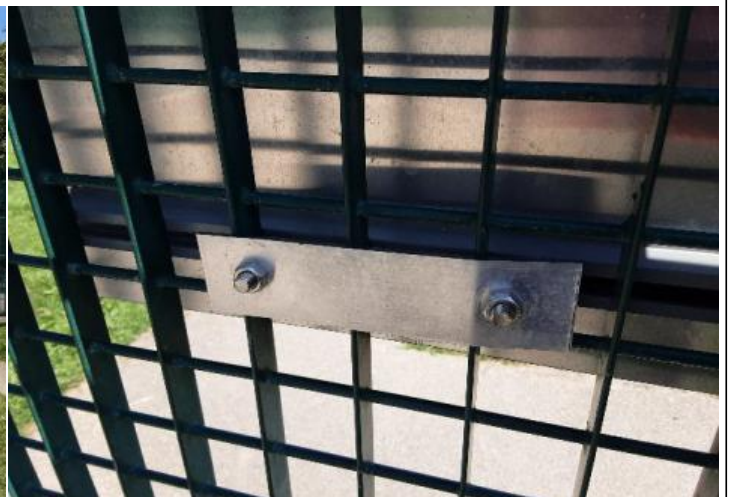
Item: Multi Use Games Area - Multi Use Games Area (MUGA)
Manufacturer: Wicksteed Playgrounds

Finding: There are projecting bolt thread(s) present

Action: Remove excess thread length and deburr or provide cap

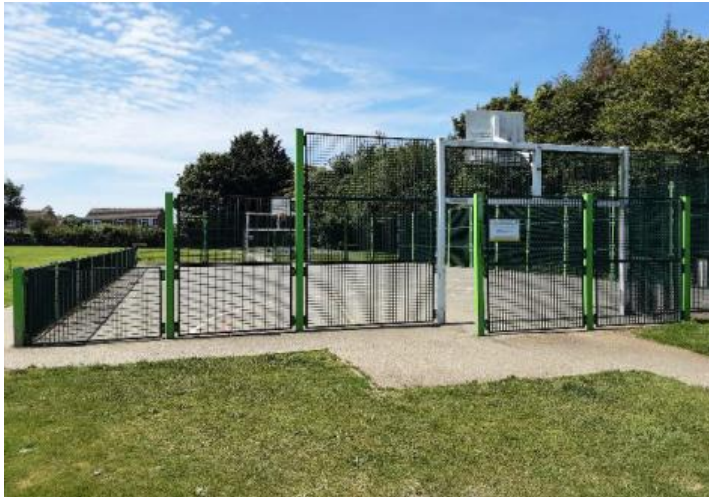
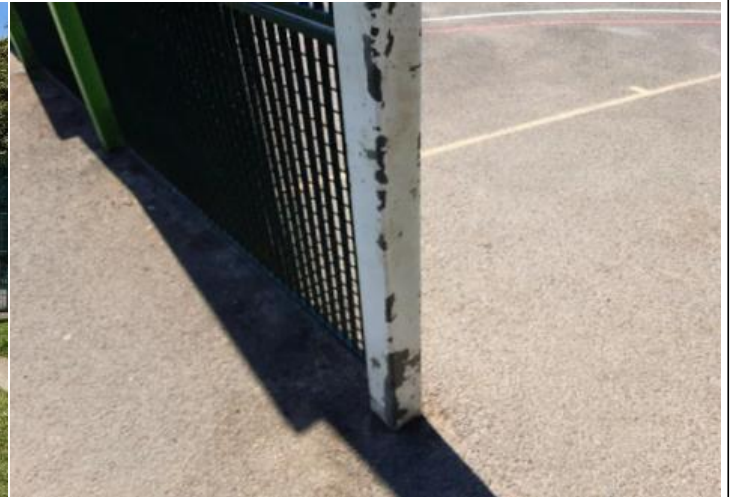
Item: Multi Use Games Area - Multi Use Games Area (MUGA) **Risk Level:** L - Low Risk
Manufacturer: Wicksteed Playgrounds **Surface:** Bitmac

Finding: The paint is flaking off the metalwork

Action: Rub down and re-paint

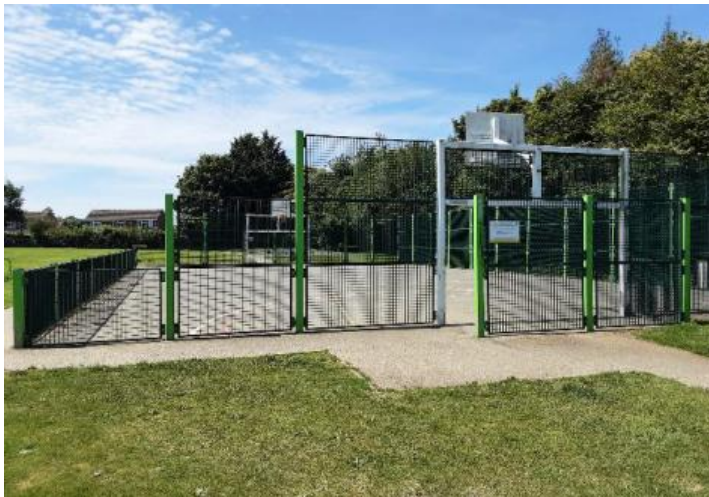
Item: Multi Use Games Area - Multi Use Games Area (MUGA) **Risk Level:** V - Very Low Risk
Manufacturer: Wicksteed Playgrounds **Surface:** Bitmac

Finding: There is/are finger entrapments in the panels and the item fails to meet the requirements of BS EN 15312 Clause 4.4.2.2 Entrapment of fingers

Action: Monitor - No remedial work recommended

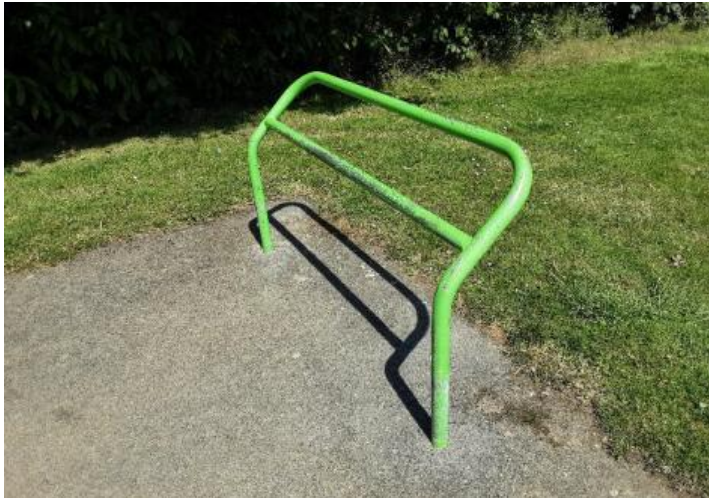
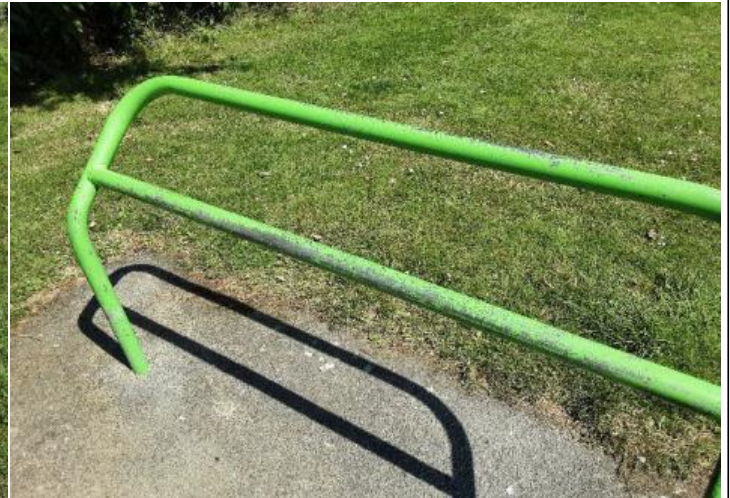
Item: Ancillary Items - Perch Seat
Manufacturer: Wicksteed Playgrounds

Finding: The paint is flaking off the metalwork

Action: Rub down and re-paint

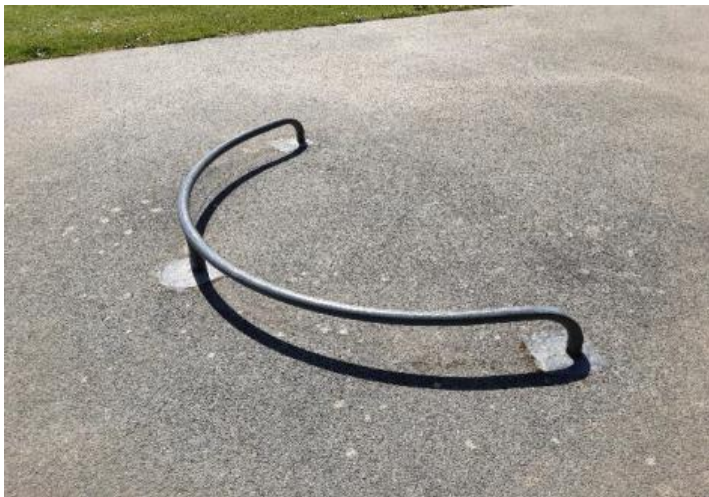
Item: Wheeled Sports - Curved Grind Rail
Manufacturer: Not Identified

Finding: The item has been damaged

Action: Monitor for any further deterioration and replace as required

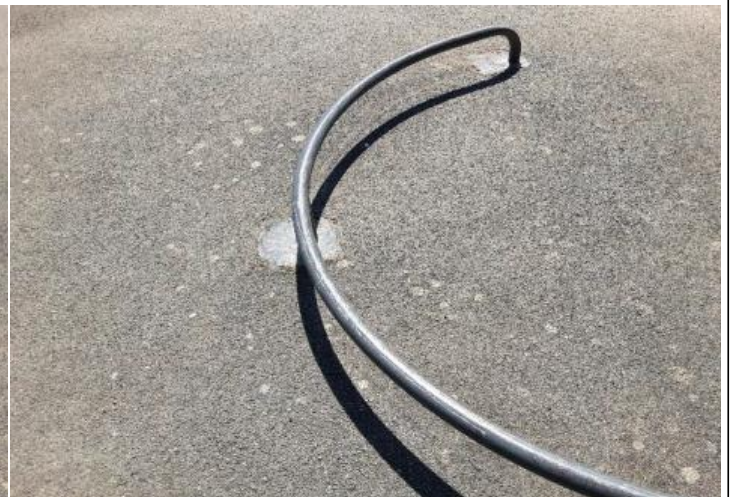
Risk Level: L - Low Risk
Surface: Bitmac

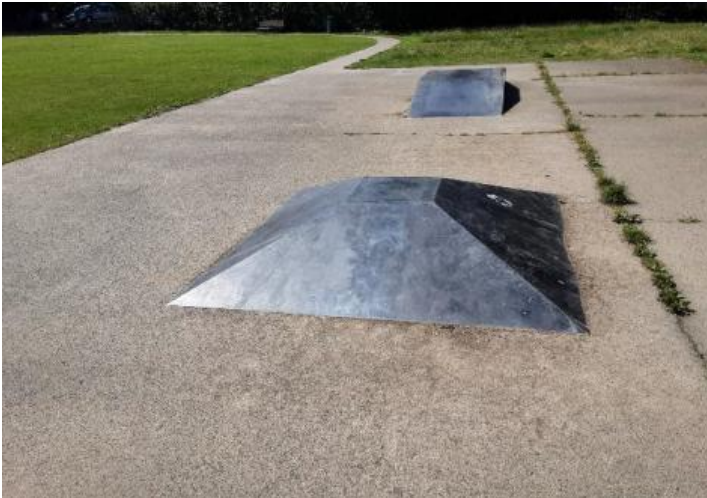
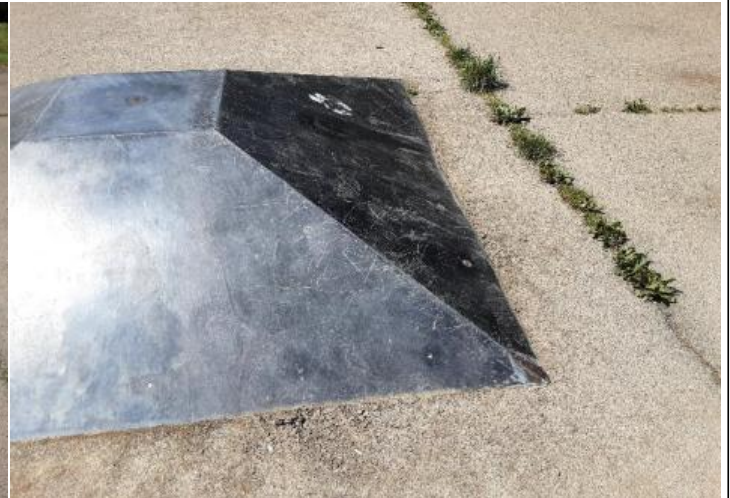
Item: Wheeled Sports - Pyramid Ramp
Manufacturer: Not Identified

Finding: The angle of the foot plate is in excess of 15 degrees in contravention of the requirements of BS EN 14974 - Part 6.1.4

Action: Monitor - no reasonably practicable action given the risk assessment
