To all Members of the Open Spaces Committee

You are hereby summoned to attend a meeting of the **OPEN SPACES COMMITTEE** at the Parish Office, Lower Green Recreation Ground, Pembury, TN2 4DZ on **Monday 30th September** at **3:00pm**.

8. **LOWER GREEN RECREATION GROUND.**
 - a. To receive RoSPA annual inspection report for play equipment and note recommendations.
 - b. To consider the option for football club to be able to store new goals on wheels in the outside section of the goal store area at the Pavilion.
 - c. To report on the meeting at Hilbert Park and consider next steps.
 - d. To consider recreation ground consultation report and agree next steps.
 - e. To consider improvements and new play equipment funded by section 106 and agree next steps.

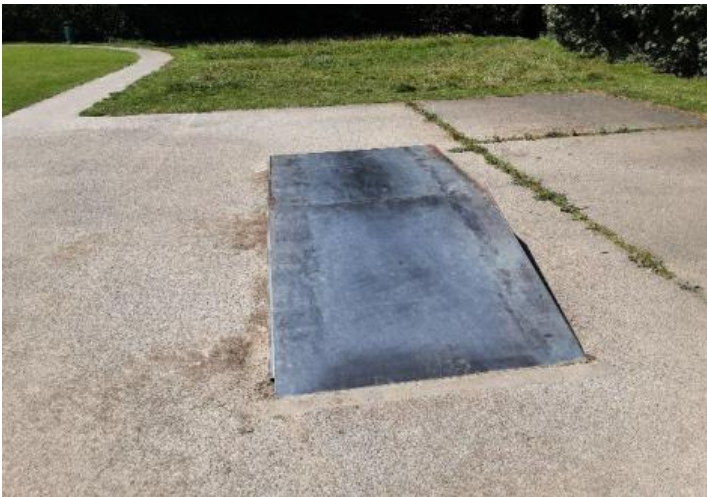
Item: Wheeled Sports - Driveway
Manufacturer: Not Identified

Finding: The paintwork on this item has been damaged or worn exposing the metal underneath which is rusting / corroding

Action: Treat affected areas and repaint

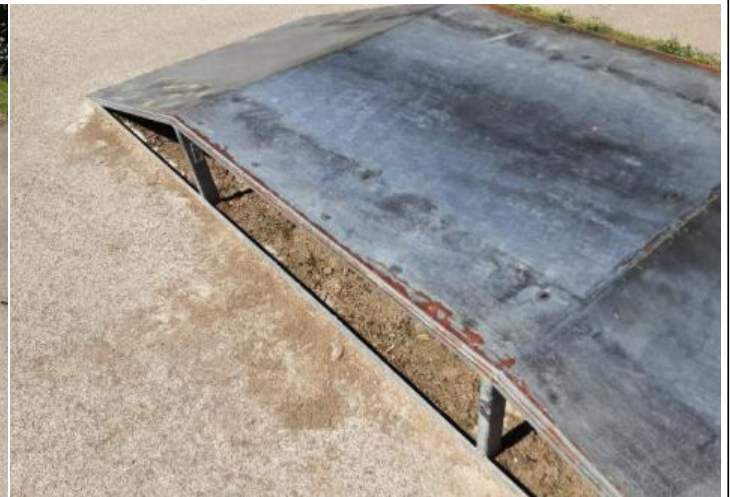
Risk Level: L - Low Risk
Surface: Bitmac

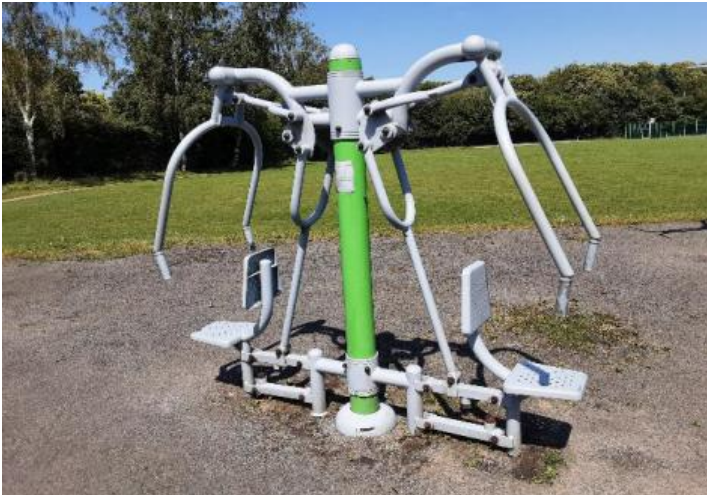
Item: Outdoor Fitness Equipment - Chest Press
Manufacturer: Wicksteed Playgrounds

Finding: The distance between the underside of the item and the ground is less than the 110mm required by BS EN 16630

Action: Monitor - No remedial work recommended

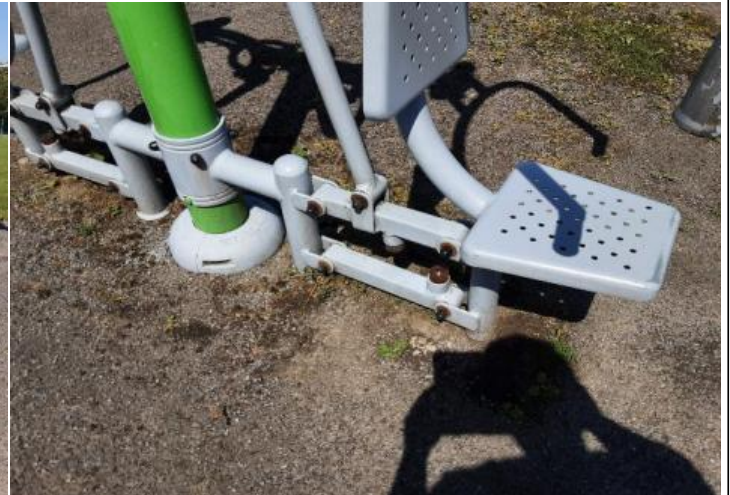
Risk Level: L - Low Risk
Surface: Bitmac

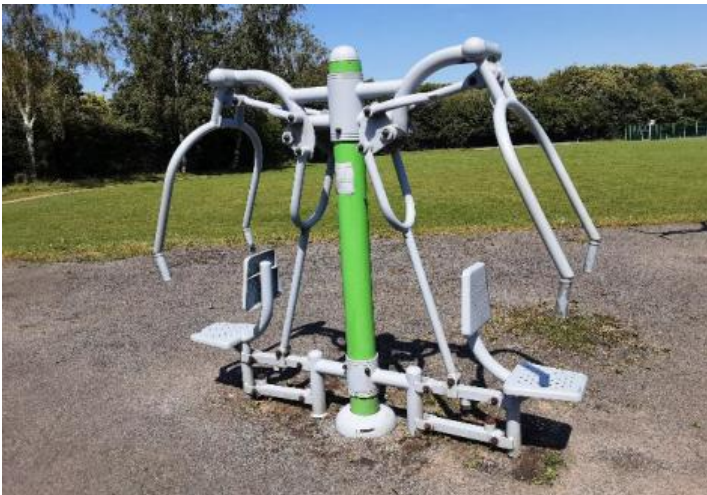
Item: Outdoor Fitness Equipment - Chest Press
Manufacturer: Wicksteed Playgrounds

Finding: The bushes are showing signs of wear

Action: Monitor for any further deterioration and replace as required

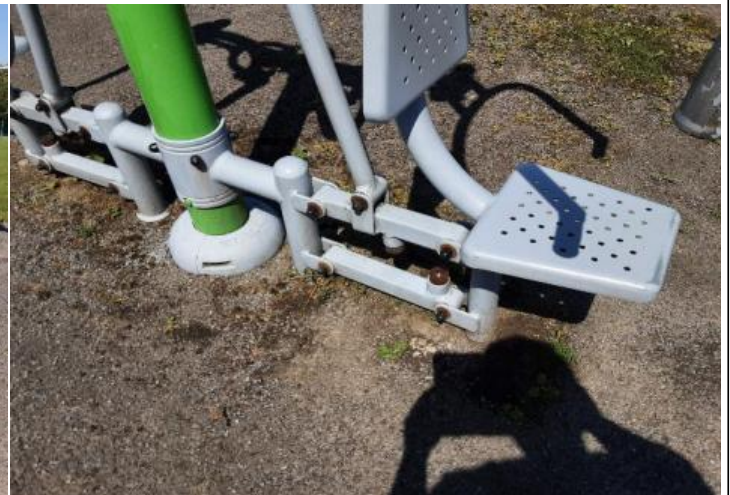
Risk Level: V - Very Low Risk
Surface: Bitmac

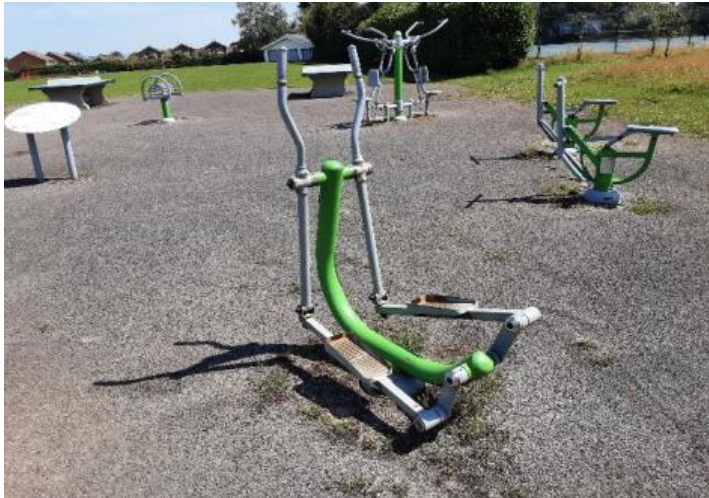
Item: Outdoor Fitness Equipment - Cross Trainer **Risk Level:** L - Low Risk
Manufacturer: Wicksteed Playgrounds **Surface:** Bitmac

Finding: The paintwork on this item has been damaged or worn exposing the metal underneath which is rusting / corroding
Action: Treat affected areas and repaint

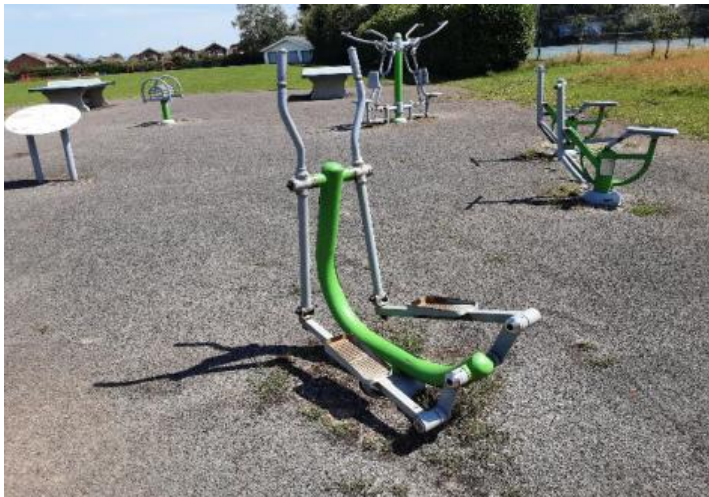
Item: Outdoor Fitness Equipment - Cross Trainer **Risk Level:** V - Very Low Risk
Manufacturer: Wicksteed Playgrounds **Surface:** Bitmac

Finding: The bushes are showing signs of wear
Action: Monitor for any further deterioration and replace as required

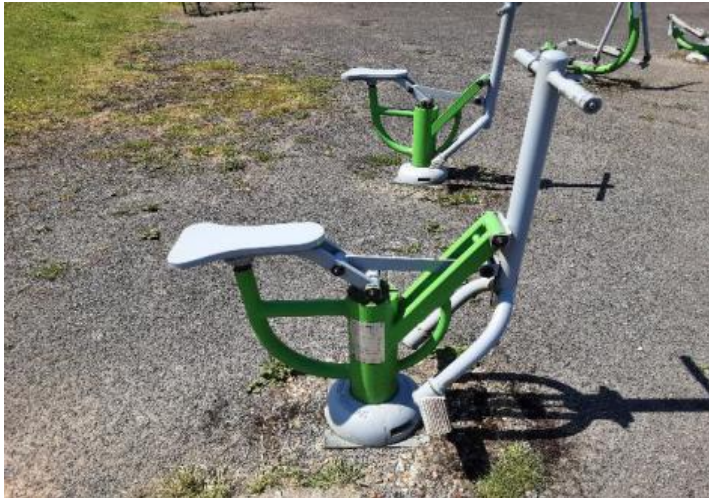
Item: Outdoor Fitness Equipment - Rider
Manufacturer: Wicksteed Playgrounds

Finding: There are gaps between 8 and 60mm creating a potential crush/shear point in contravention of the requirements of BS EN 16630

Action: Monitor - No remedial work recommended

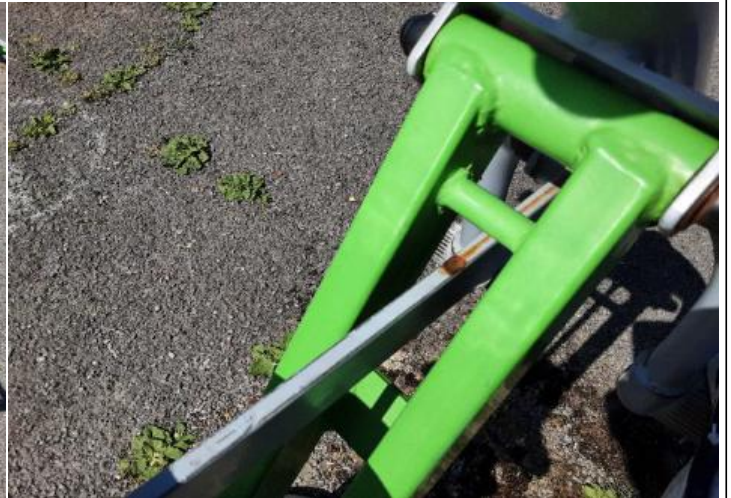
Risk Level: L - Low Risk
Surface: Bitmac

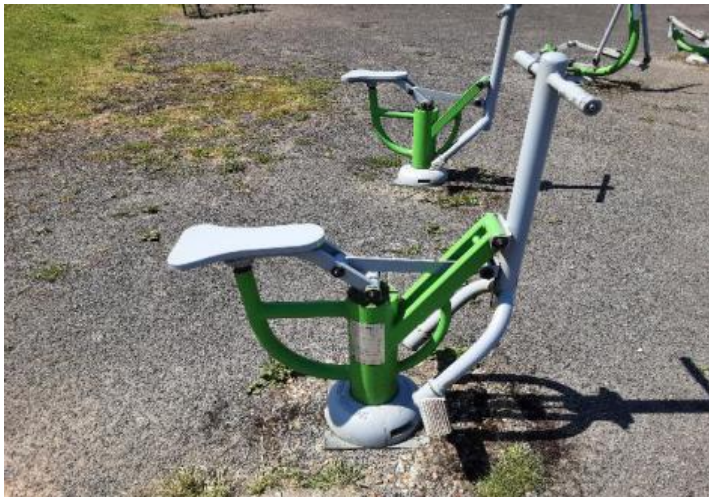
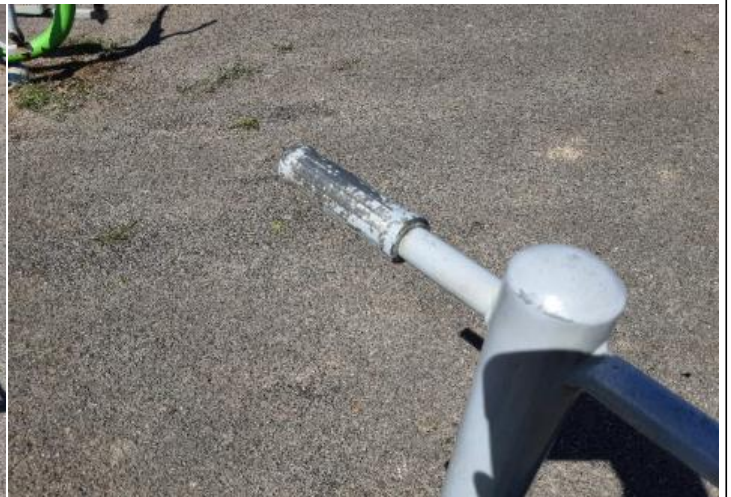
Item: Outdoor Fitness Equipment - Rider
Manufacturer: Wicksteed Playgrounds

Finding: The paint is flaking off the metalwork

Action: Rub down and re-paint

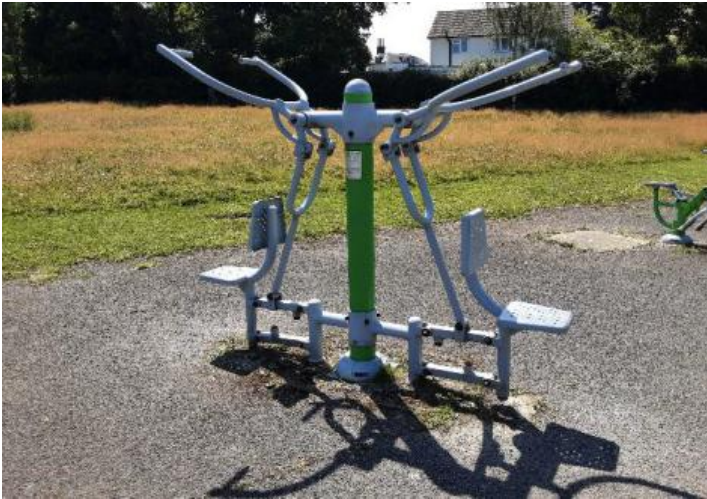
Item: Outdoor Fitness Equipment - Lateral Pull Down
Manufacturer: Wicksteed Playgrounds

Finding: The distance between the underside of the item and the ground is less than the 110mm required by BS EN 16630

Action: Monitor - No remedial work recommended

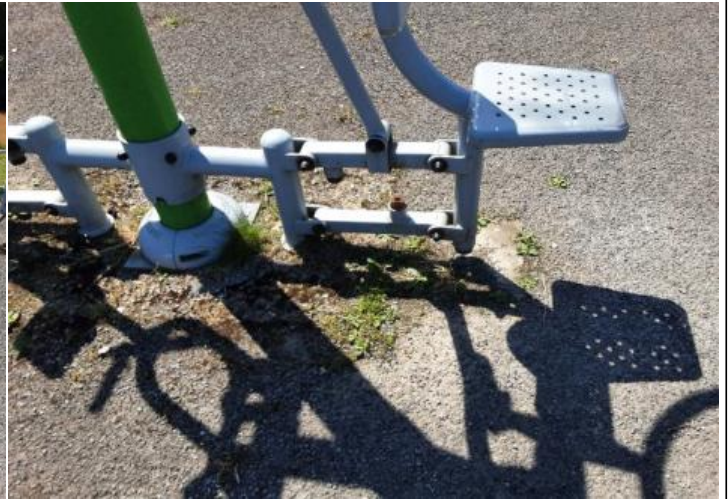
Risk Level: L - Low Risk
Surface: Bitmac

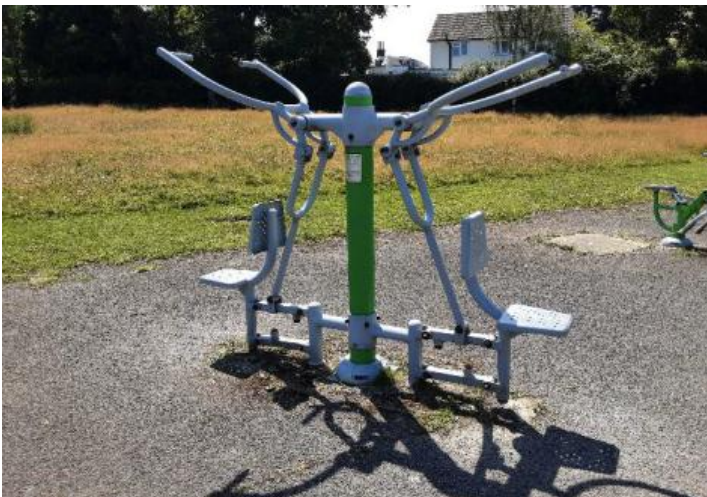
Item: Outdoor Fitness Equipment - Lateral Pull Down
Manufacturer: Wicksteed Playgrounds

Finding: The bushes are showing signs of wear

Action: Monitor for any further deterioration and replace as required

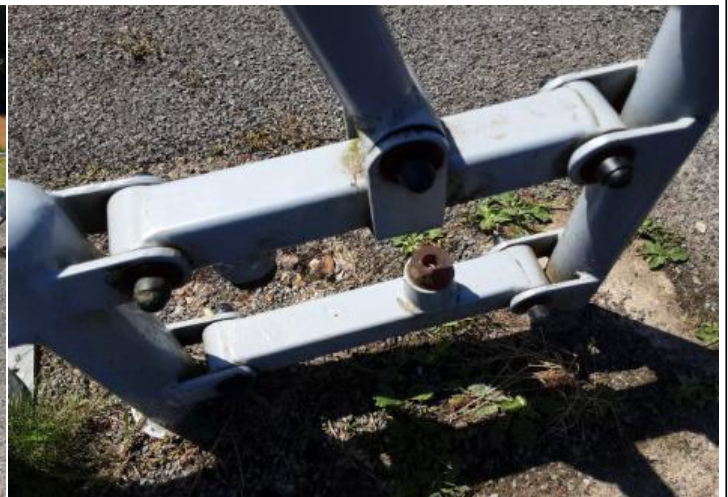
Risk Level: V - Very Low Risk
Surface: Bitmac

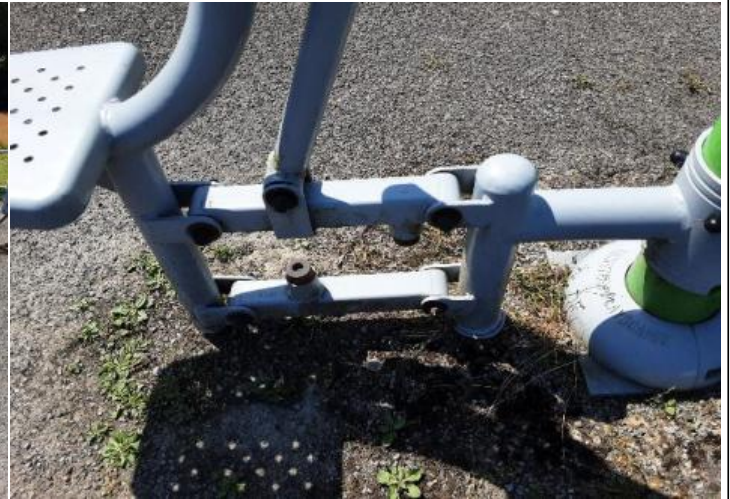
Risk Level: V - Very Low Risk
Surface: Bitmac

Finding: There is/are bolt cap covers missing or damaged on the item

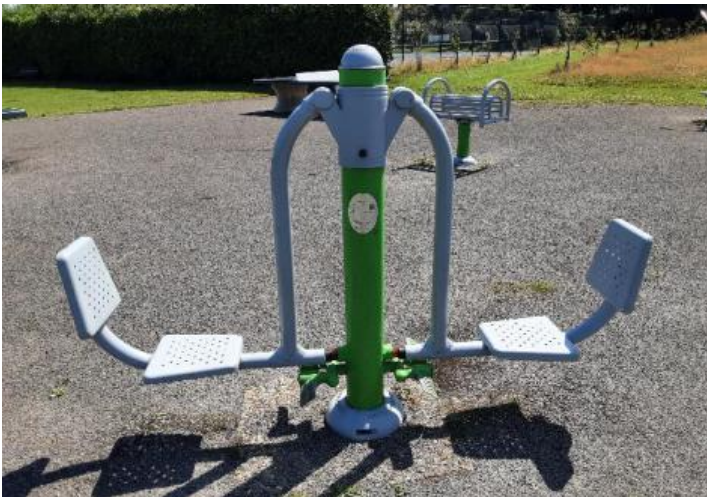
Item: Outdoor Fitness Equipment - Leg Press
Manufacturer: Wicksteed Playgrounds

Finding: The bushes are showing signs of wear

Action: Monitor for any further deterioration and replace as required

69	Leg press	Bushes showing signs of wear	Monitor for further deterioration and replace as required	4	Very low risk			Monitor

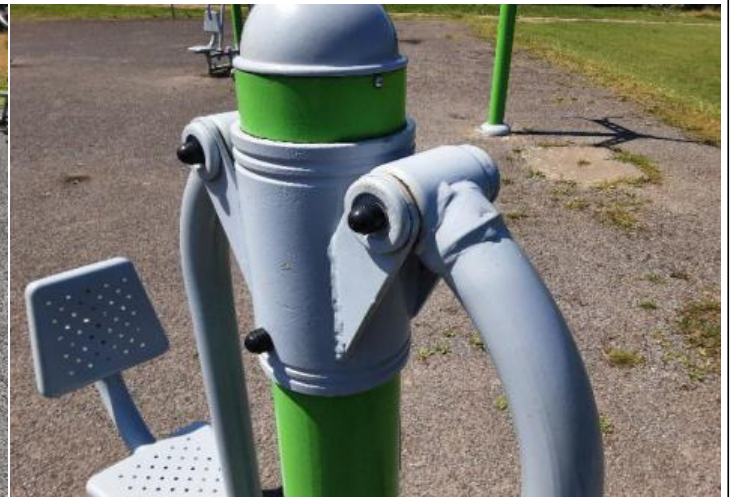
Risk Level: V - Very Low Risk
Surface: Bitmac
